MAINTENANCE SERVICES FOR:
CITY WATER RESEVOIR TANKS

1,521,971 GALLON ON-GRADE WELDED STEEL RESERVOIR

INSPECTION REPORT**1,521,971 Gallon****On-Grade Welded Steel****Water Tank****Dimensions: 90'D x 32'H****Inspection Date: 03-05-2013****Section A-2: General**

5,397,826 GALLON ON-GRADE WELDED STEEL RESERVOIR

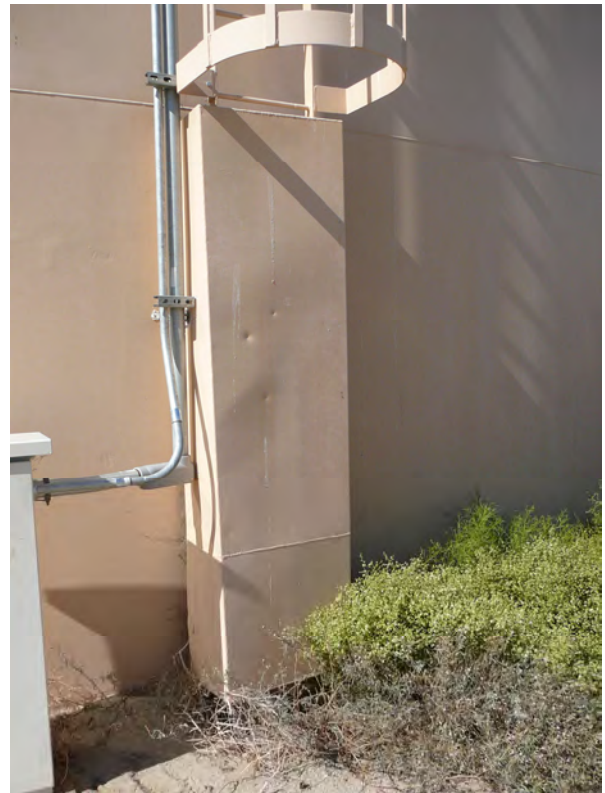
4. Ladder Security

The site has a protective fence, ladder gate and lock, and access hatch lock. No evidence of vandalism was observed

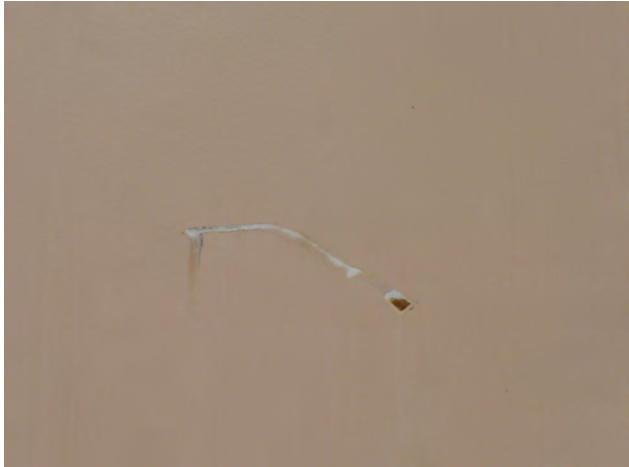
11. Shell Paint Scratch

The exterior paint on course 1-4 was found to be in excellent condition with the exception of a few minor scratches (picture #11). The roof paint was in excellent condition.

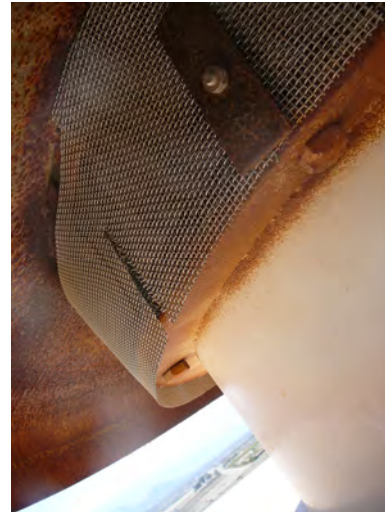
16. Roof Vent Screen

The tank roof vent screen was present and in good condition. The tank roof penetrations were all covered. Site was clear of standing water and any observable sources of contamination.

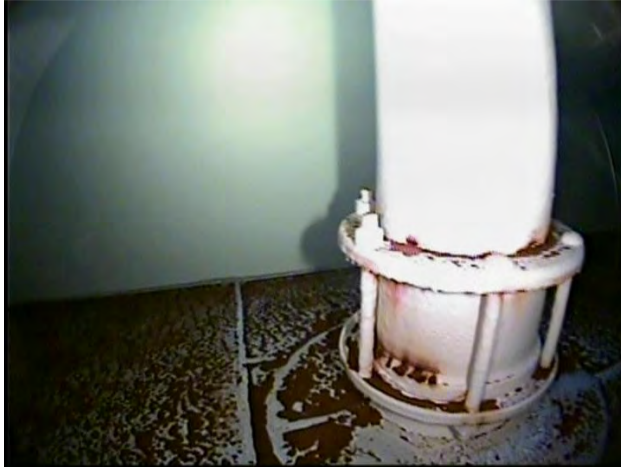
23. Overflow Pipe Base

The overflow was in good condition, with minor rust in center section.

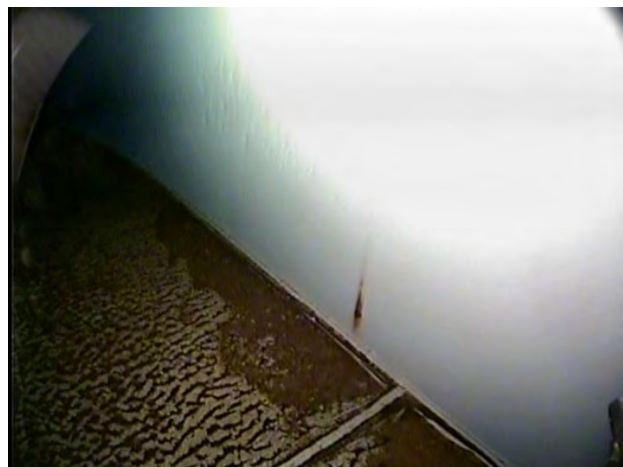
32. Wall Rust Nodule

Interior tank walls are in excellent condition except 12"-18" from floor a few rust nodules have developed (picture #30, 31, 32). Epoxy repair can easily prevent these nodules from further tank corrosion.

1. The interior rust nodules need epoxy painting repairs done immediately to prevent further corrosion.
2. Clean tank sediment from floor. Chlorine disinfection is only effective to depths less than 1/4".
3. Re-check reservoir ventilation engineering. The vent may be undersized for the flow capacity of this reservoir (see pg.14). Also check for compliance with inlet/outlet, Silt Trap, and Sample Port codes and standards
4. Tank cleaning is recommended every 3 to 5 years.

1. Epoxy repairs for interior rust nodules particularly in section 1 of wall 12"-18" from floor.
2. Clean sediment from tank floor. Chlorine disinfection is only effective at depths less than 1/4".
3. Recommend re-checking engineering for adequate reservoir ventilation. The roof center vent on this tank may be undersized for the inflow/outflow rate of this reservoir. Additional ventilation is also recommended to minimize condensation on the interior roof of the tank. Condensation contributes to premature coating failure and corrosion of the roof structure.
AWWA standard (D100-11 Sec 5.5): Tanks equipped with roofs shall have a vent above the top capacity level, which shall have a capacity to pass air so that the maximum flow rate of water, either entering or leaving the tank, excessive pressure will not be developed. The overflow pipe shall not be considered a tank vent.

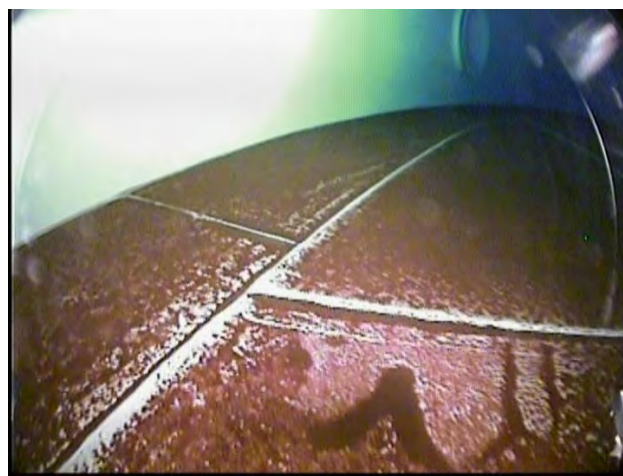
33. Floor Sediment

The tank floor was covered with 1/8" to 1/4" of sediment (loose silt and sand). **The sediment needs to be cleaned before a floor inspection is complete (pictures #32, 33).**

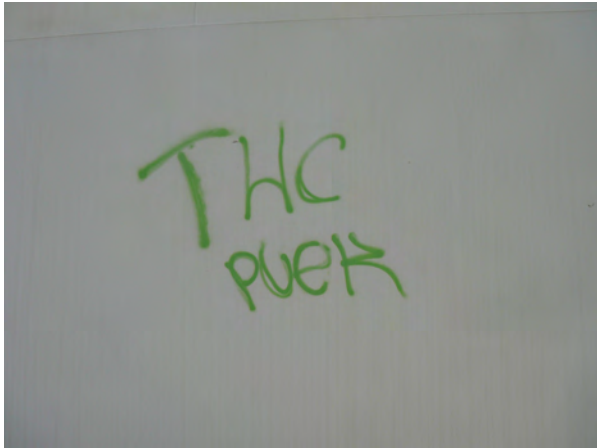
6. Exterior Shell Graffiti

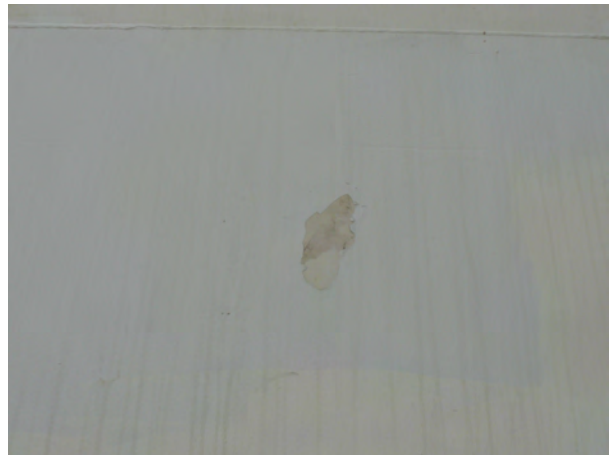
9. Shell Course 1 Peeling Paint

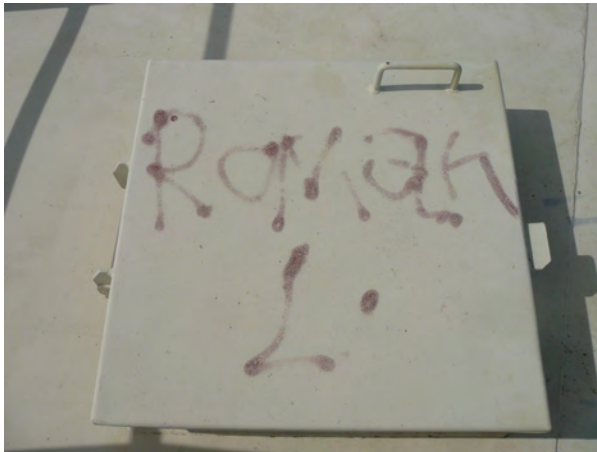
7. Roof Hatch Graffiti

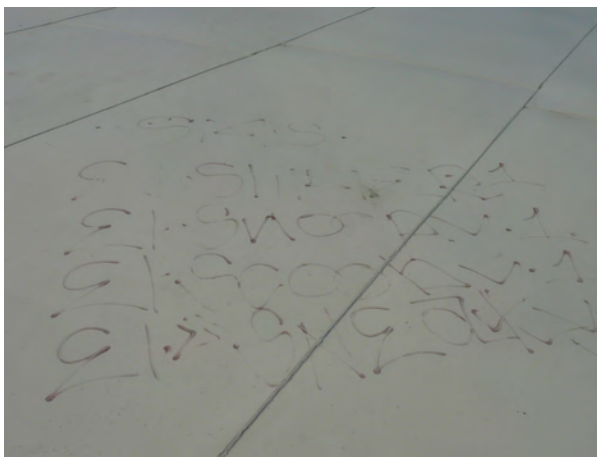
8. Roof Graffiti

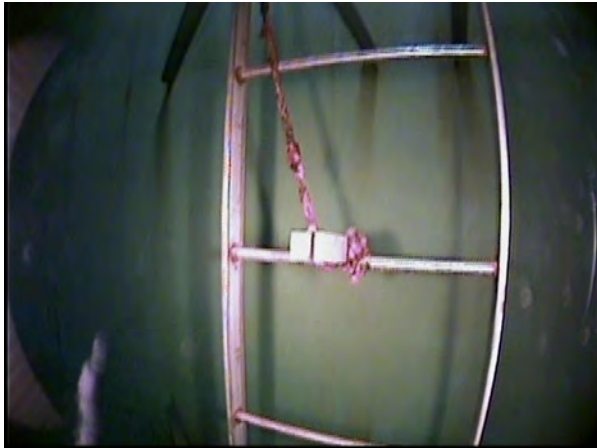
23. Interior Ladder Safety Climb

Reservoir Interior	Condition					Pictures	Comments
Component	NA	Ex	Good	Fair	Poor	#'s	
Access Hatch (1)			X				
Access Hatch Gasket(1)			X				
Ladder			X				
Safety Climb					X	23,24	broken,corrosion, need to remove
Plumbing							
Inlet			X			25,26	Blistering/Corrosion
Outlet			X				Blistering/Corrosion
Outlet Silt Trap	X						in shell wall
Overflow			X				
Columns							
Center Support Column				X		27,28	50% coating failure
Satellite Columns				X		29,30	50% coating failure
Manway Access (2)			X			32	Blistering/Corrosion
Manway Gaskets (2)		X				32	
Cathodic Protection	X						None
Assembly	X						
Float	X						
Anodes	X						
Sample Port (2)				X		33	1 port partially blocked/corrosion
Ceiling						34	little condensation, staining
Quadrant 1			X				little condensation, staining
Quadrant 2			X				little condensation, staining
Quadrant 3			X				little condensation, staining
Quadrant 4			X				little condensation, staining

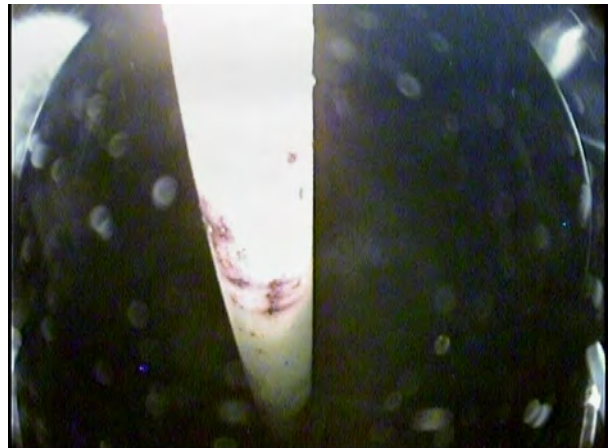
28. Center Column Corrosion

Column coating was cracked, and corrosion present.

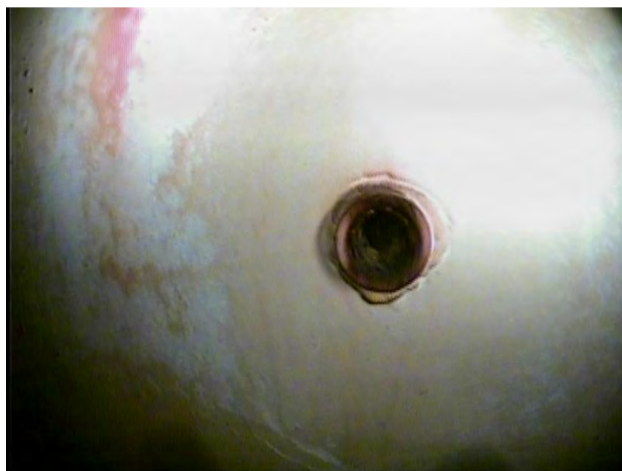
33. Sample Port Interior Corrosion

Some blistering was present on the internal inlet and outlet. The overflow was in good condition. One sample port was partially clogged by corrosion.

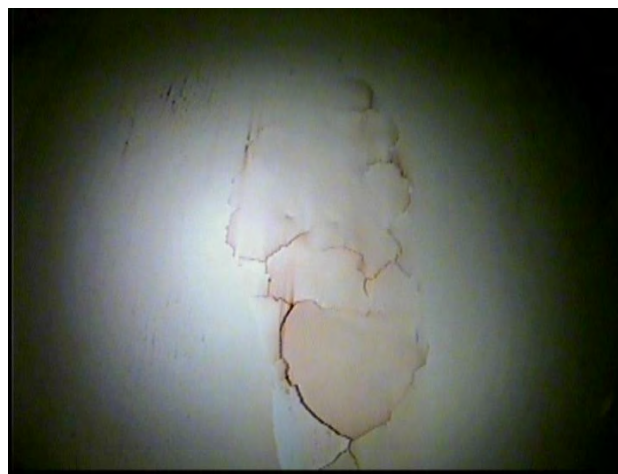
38. Wall Peeling and Flaking Coating

Interior tank walls have extensive areas of coating failure with heavy corrosion. Overall the tank walls were in poor condition.

1. The interior walls of this tank need to be sandblasted and recoated or extensive epoxy painting repairs done immediately. Excessive corrosion exists and will continue.
2. Exterior Light Lens cover is broken, needs replacement.
3. Clean Tank sediment and debris from floor. Chlorine disinfection is only effective to depths of less than 1/4".
4. Remove interior ladder safety climb cable and brackets. Cable is broken and corroding on tank floor.
5. Remove film on water surface by running tank to overflow for a sufficient period of time.
6. Tank cleaning is recommended every 3 to 5 years.

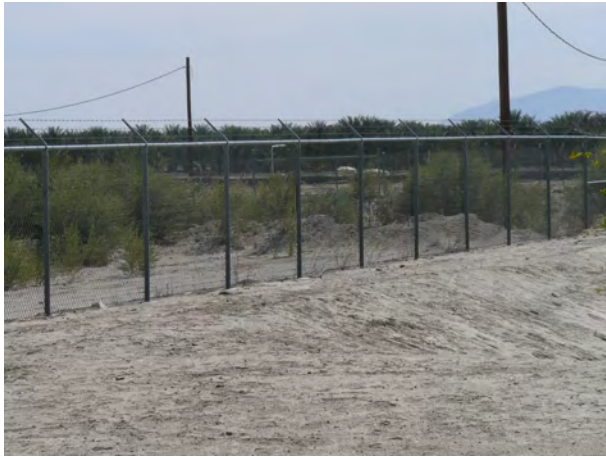
1. Protective Fence (Typical)

Reservoir Exterior	Condition					Pictures #s	Comments
	NA	Ex	Good	Fair	Poor		
Component							
Site Security							
Protective Fence		X				1	7' protective chain link fence
Out Building(s)		X				2	
Exterior Ladder		X				4	
Ladder Lock/Gate		X				4	Cage ladder with Lock
Ladder Safety Climb		X				4	
Site Condition							level site, near residential
Surface Water		X					
Landslide Risk		X					
100'+ to Waste Facility		X					
50'+ to Sanitary Sewer		X					
Standing Surface Water		X					
Foundation		X				3	Concrete
Vandalism							
Sidewall				X		5	graffiti, broken lens
Roof					X	6,7	heavy graffiti
Site		X
