Appendix F1: Feasibility-Level Geotechnical Evaluation

*REVISED FEASIBILITY-LEVEL GEOTECHNICAL EVALUATION
KPC COACHELLA PROJECT
2,850-ACRES± OF VACANT LAND NORTH OF INTERSTATE 10
AND EAST OF THE ALL-AMERICAN CANAL
CITY OF COACHELLA, RIVERSIDE COUNTY, CALIFORNIA*

*March 23, 2023
J.N. 16-368
Revision 2*

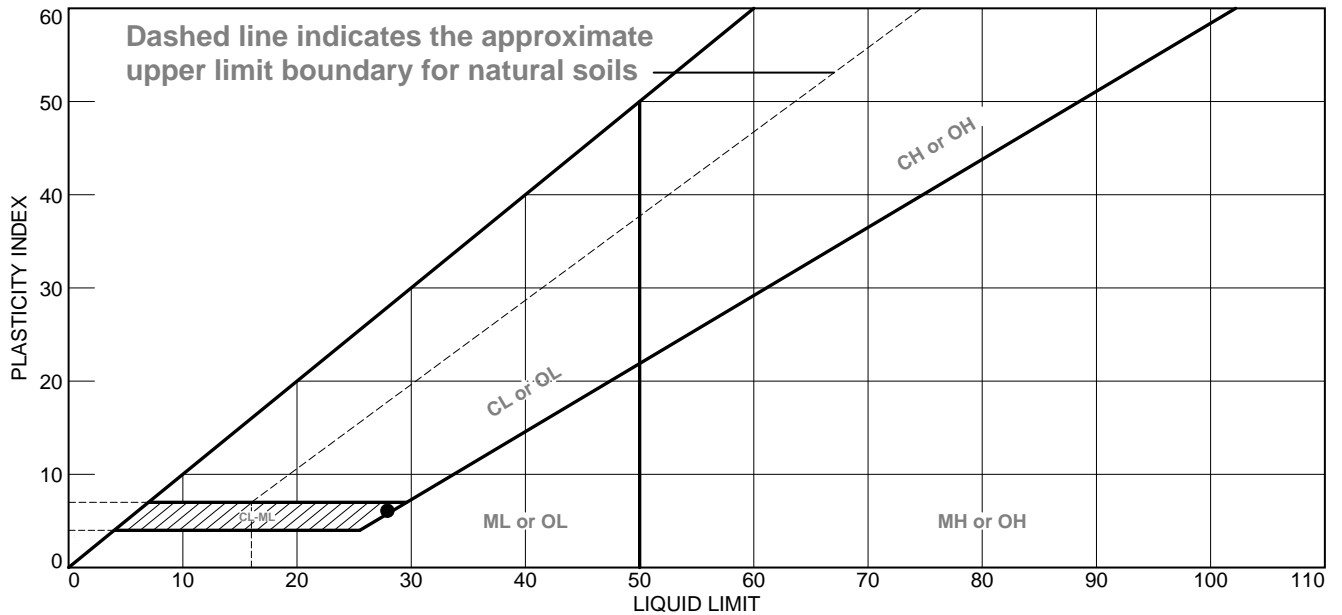
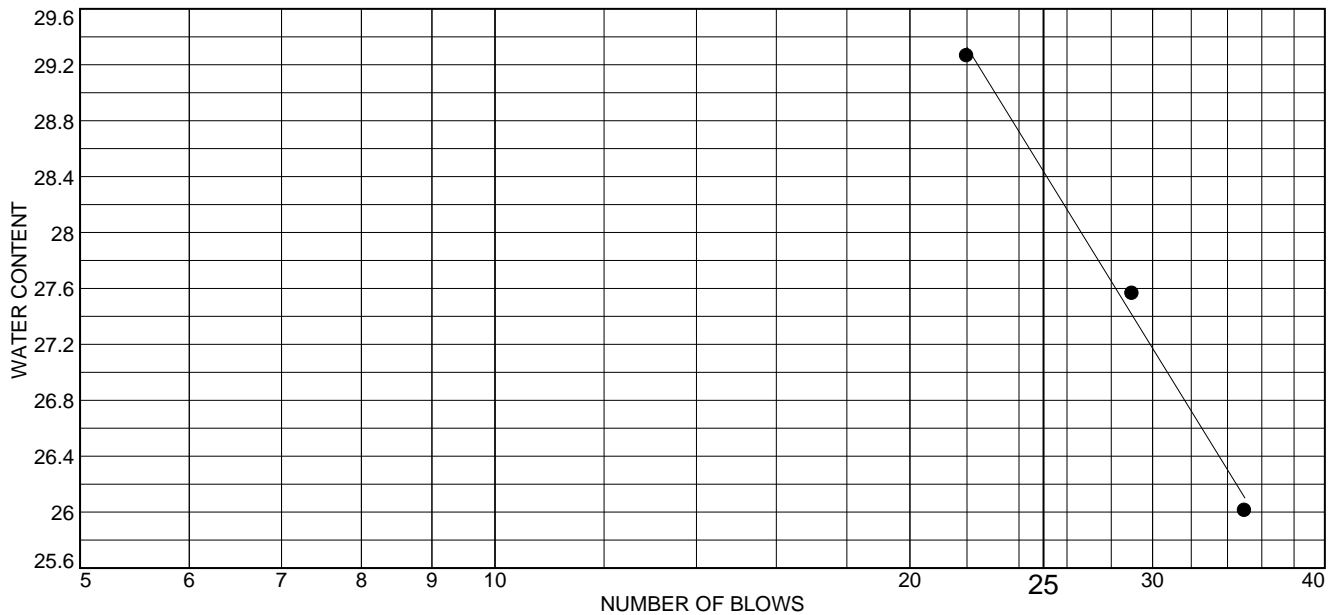
LIQUID AND PLASTIC LIMITS TEST REPORT

MATERIAL DESCRIPTION	LL	PL	PI	%<#40	%<#200	USCS
●	Grayish Brown, Sandy Silt	28	22	6

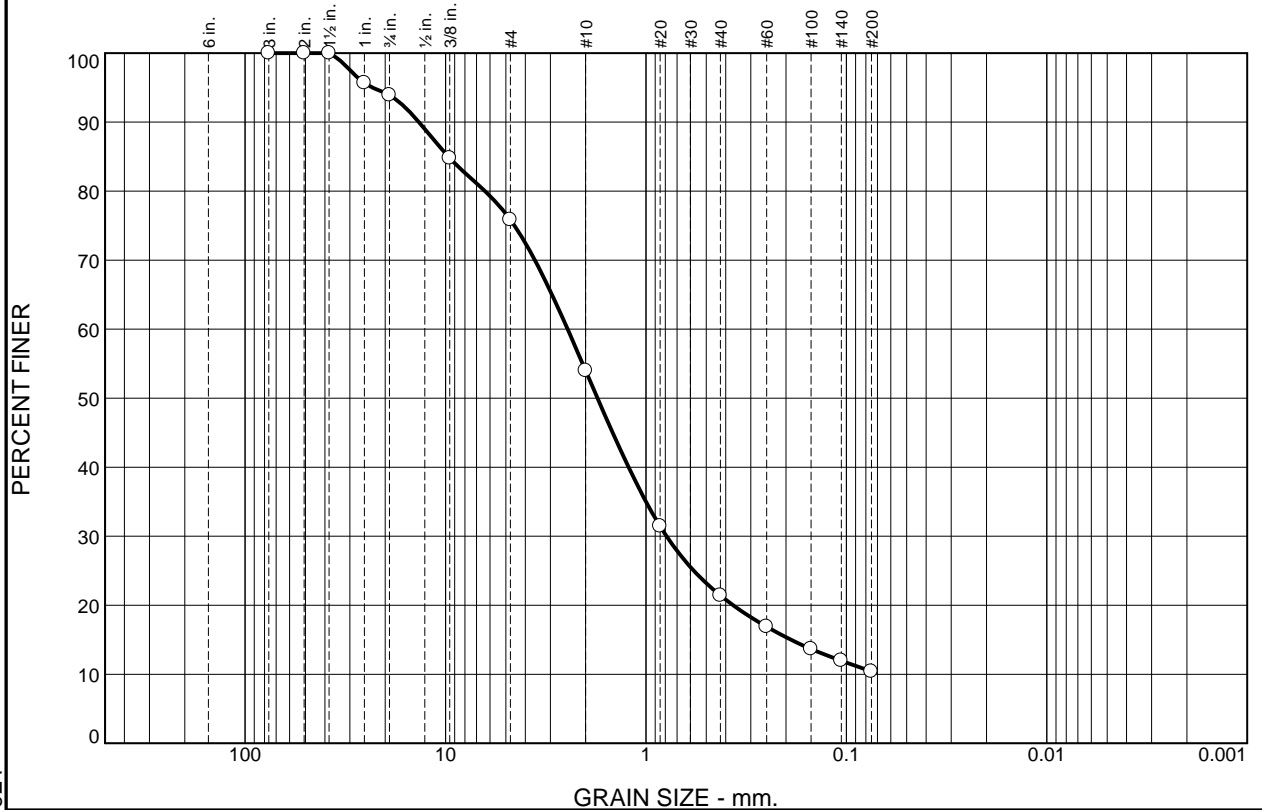
Particle Size Distribution Report

% +3"	% Gravel		% Sand			% Fines	
	Coarse	Fine	Coarse	Medium	Fine	Silt	Clay
0.0	6.1	18.0	21.9	32.6	11.0	10.4

SIEVE SIZE	PERCENT FINER	SPEC.* PERCENT	PASS? (X=NO)
3	100.0		
2	100.0		
1.5	100.0		
1	95.7		
.75	93.9		
.375	84.8		
#4	75.9		
#10	54.0		
#20	31.5		
#40	21.4		
#60	16.9		
#100	13.7		
#140	12.0		
#200	10.4

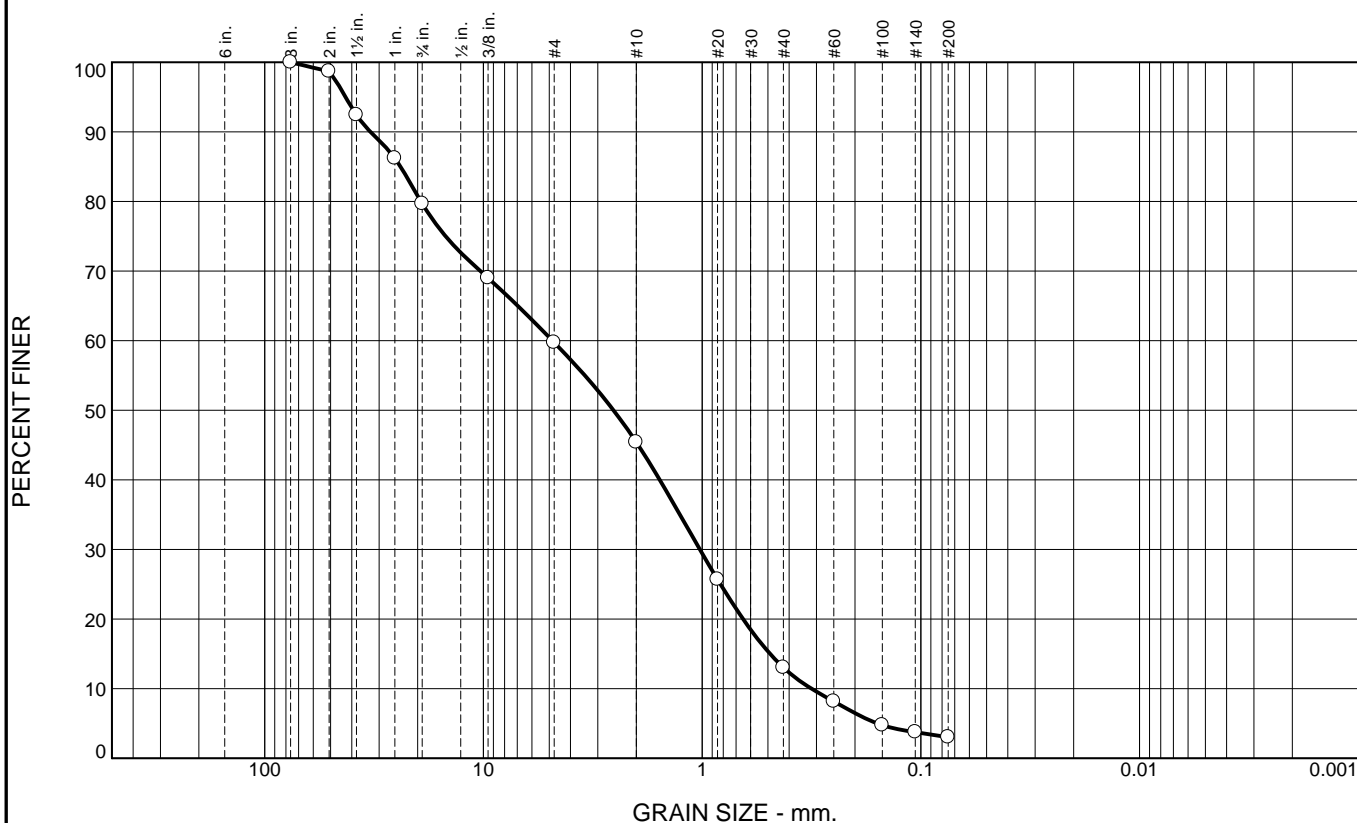
Particle Size Distribution Report

% +3"	% Gravel		% Sand			% Fines	
	Coarse	Fine	Coarse	Medium	Fine	Silt	Clay
0.0	20.3	20.0	14.3	32.4	10.0	3.0

SIEVE SIZE	PERCENT FINER	SPEC.* PERCENT	PASS? (X=NO)
3	100.0		
2	98.7		
1.5	92.4		
1	86.2		
.75	79.7		
.375	69.0		
#4	59.7		
#10	45.4		
#20	25.7		
#40	13.0		
#60	8.2		
#100	4.8		
#140	3.8		
#200	3.0

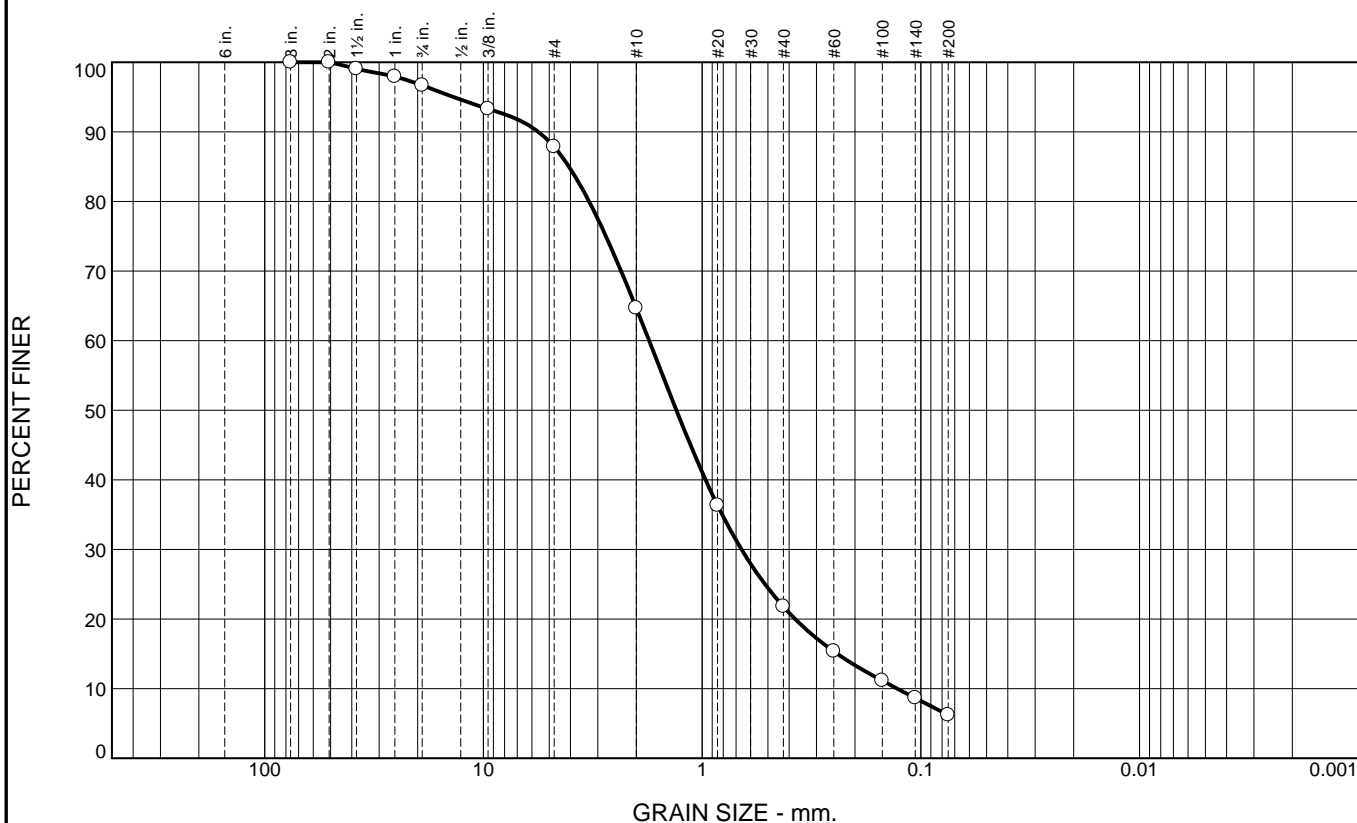
Particle Size Distribution Report

% +3"	% Gravel		% Sand			% Fines	
	Coarse	Fine	Coarse	Medium	Fine	Silt	Clay
0.0	3.3	8.8	23.2	42.9	15.6	6.2

SIEVE SIZE	PERCENT FINER	SPEC.* PERCENT	PASS? (X=NO)
3	100.0		
2	100.0		
1.5	99.0		
1	97.9		
.75	96.7		
.375	93.3		
#4	87.9		
#10	64.7		
#20	36.3		
#40	21.8		
#60	15.4		
#100	11.1		
#140	8.7		
#200	6.2

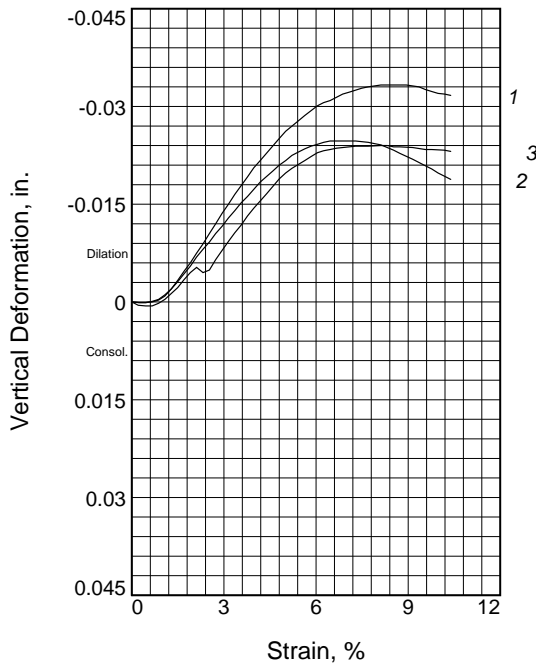
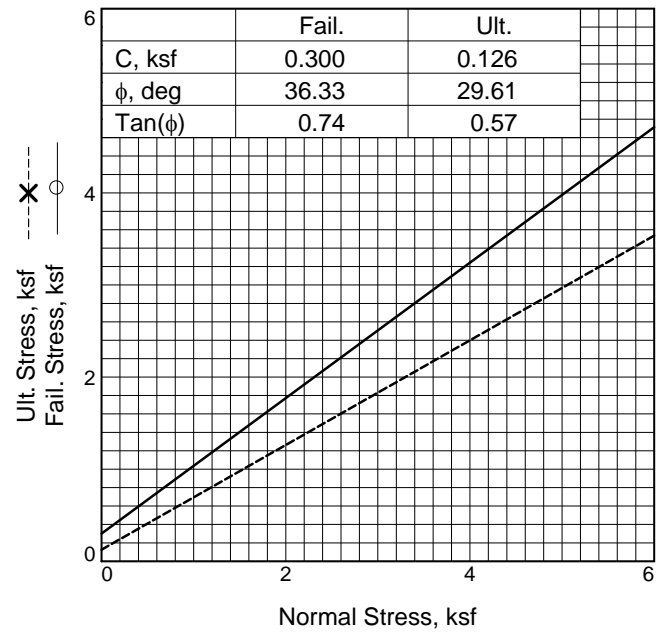
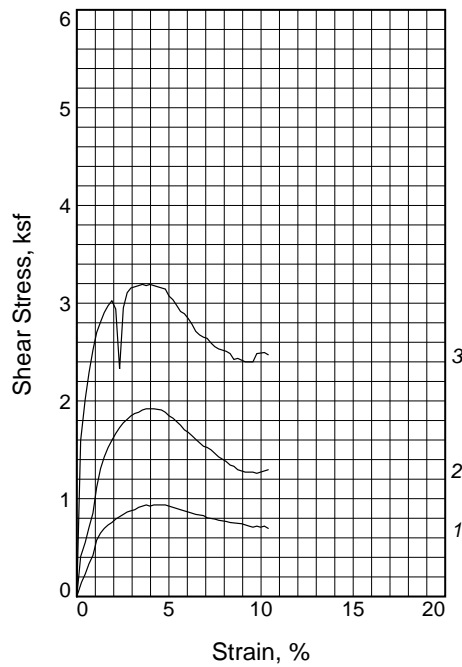
Sample No.		1	2	3
Initial	Water Content, %	1.4	1.4	1.4
	Dry Density, pcf	118.1	118.1	114.7
	Saturation, %	9.2	9.2	8.3
	Void Ratio	0.4007	0.4007	0.4427
	Diameter, in.	2.416	2.416	2.416
	Height, in.	1.000	1.000	1.000
At Test	Water Content, %	14.5	14.1	15.5
	Dry Density, pcf	119.5	120.3	117.4
	Saturation, %	99.7	99.5	100.0
	Void Ratio	0.3846	0.3746	0.4096
	Diameter, in.	2.416	2.416	2.416
	Height, in.	0.989	0.981	0.977
Normal Stress, ksf		1.000	2.000	4.000
Fail. Stress, ksf		0.936	1.920	3.192
Strain, %		3.8	3.8	3.6
Ult. Stress, ksf		0.696	1.260	2.400
Strain, %		10.4	9.8	9.6
Strain rate, in./min.		0.040	0.040	0.040

Sample Type: Undisturbed
Description: Light Brown, Silty fine to coarse Sand
Specific Gravity= 2.65
Remarks:

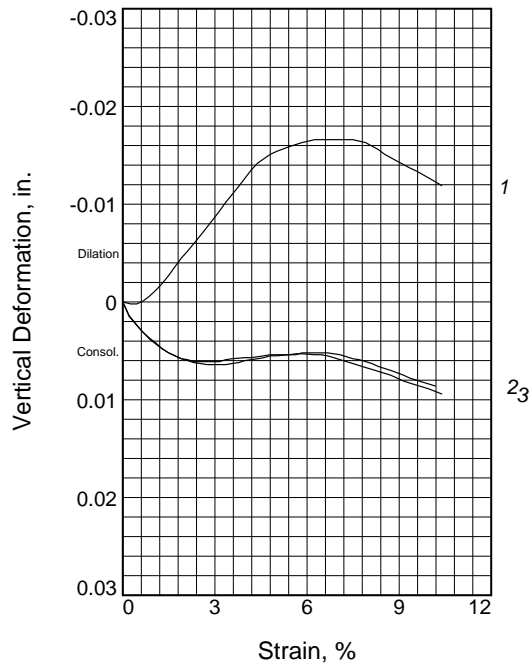
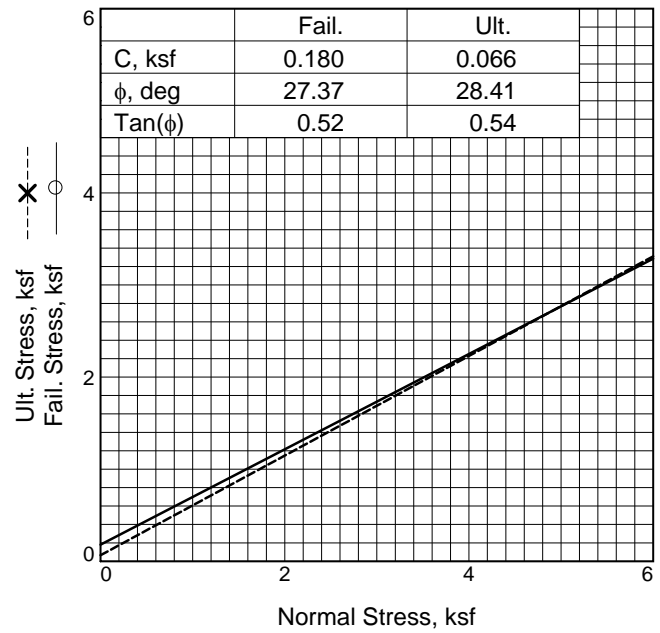
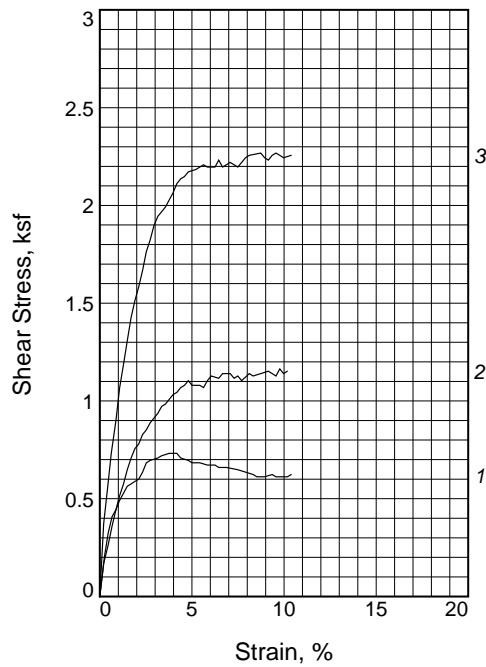
Sample No.		1	2	3
Initial	Water Content, %	0.8	0.8	0.8
	Dry Density, pcf	103.8	103.8	103.8
	Saturation, %	3.6	3.6	3.6
	Void Ratio	0.5939	0.5939	0.5939
	Diameter, in.	2.416	2.416	2.416
	Height, in.	1.000	1.000	1.000
At Test	Water Content, %	21.4	20.4	19.8
	Dry Density, pcf	105.6	107.4	108.4
	Saturation, %	100.0	99.8	99.9
	Void Ratio	0.5665	0.5404	0.5267
	Diameter, in.	2.416	2.416	2.416
	Height, in.	0.983	0.966	0.958
Normal Stress, ksf		1.000	2.000	4.000
Fail. Stress, ksf		0.732	1.164	2.268
Strain, %		3.8	9.8	8.7
Ult. Stress, ksf		0.612	1.140	2.232
Strain, %		8.5	10.0	9.1
Strain rate, in./min.		0.040	0.040	0.040

Sample Type: Undisturbed

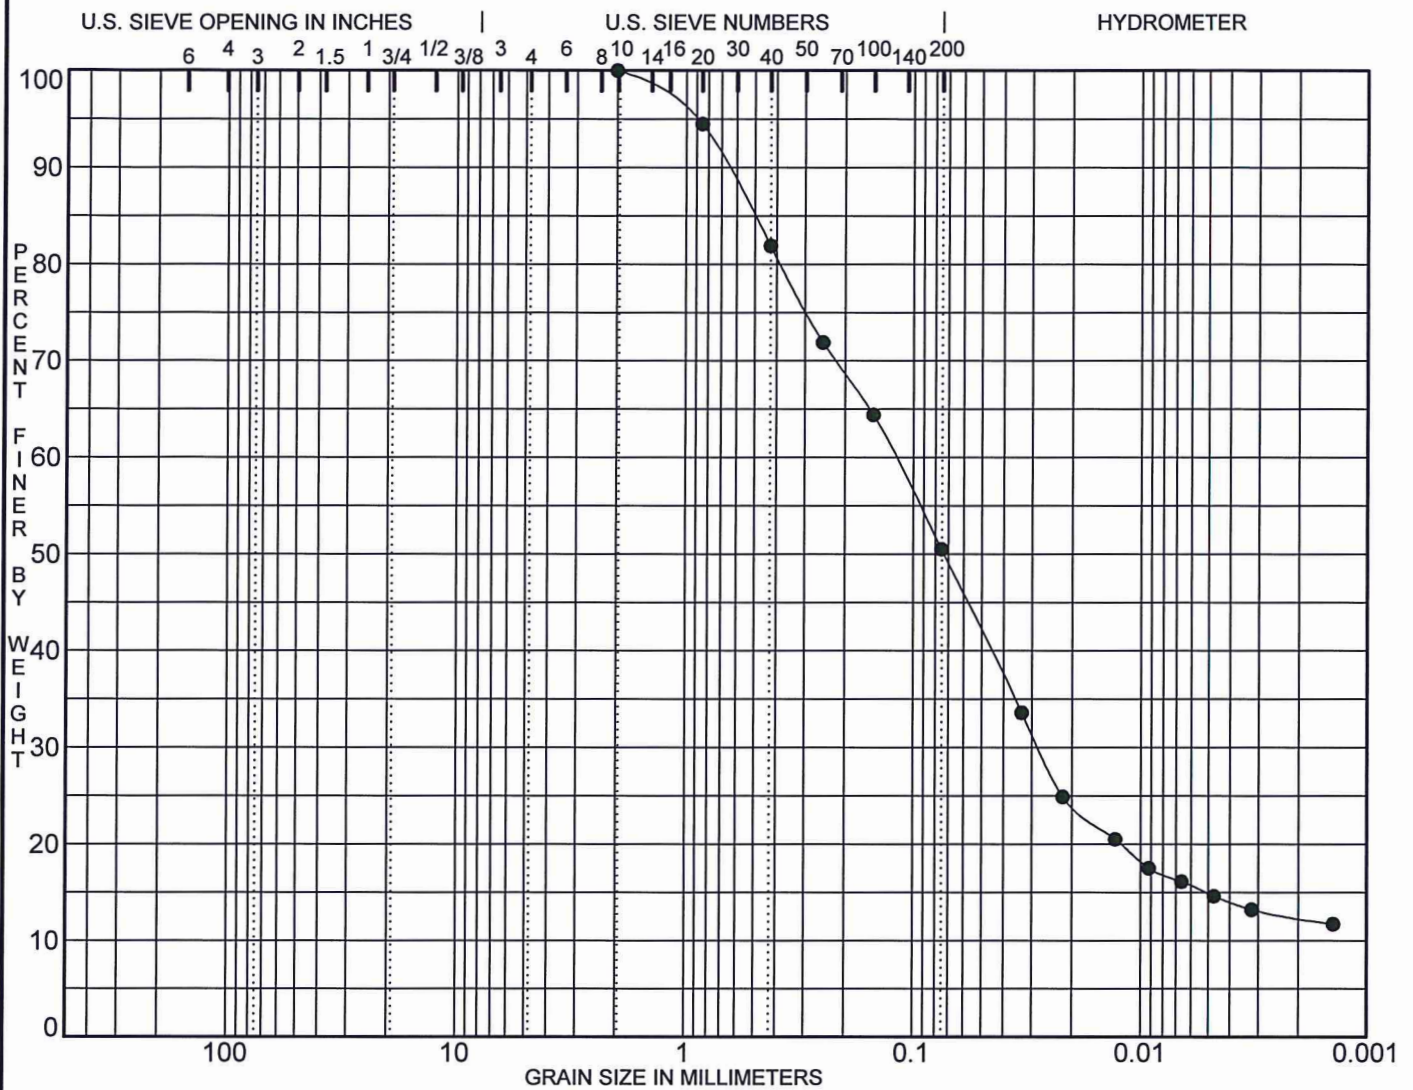
J.N. 376-11	GRAIN SIZE ANALYSIS	February, 2013
PETRA GEOTECHNICAL, INC.		PLATE B-5

Specimen Identification	Classification	MC%	LL	PL	PI	Cc	Cu
● B-13 0.0	Sandy Silt (ML) - Palm Spring Formation		30	22	8

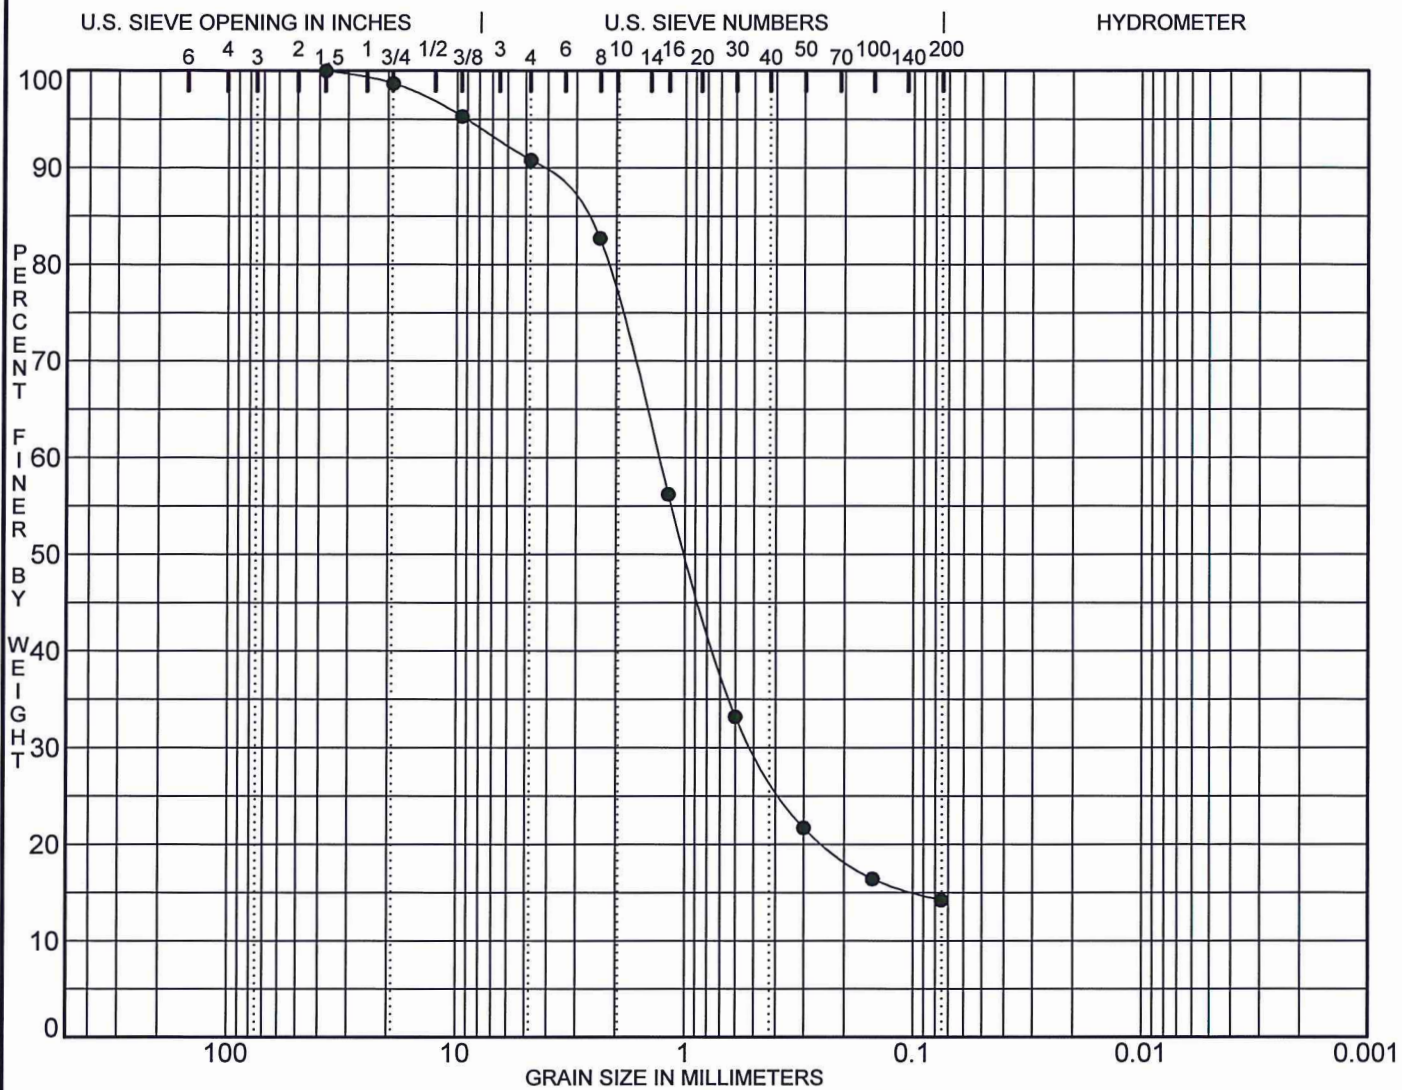
PLATE B-6

Specimen Identification	Classification	MC%	LL	PL	PI	Cc	Cu
● B-18 15.0	Silty Sand (SM) - Ocotillo Conglomerate

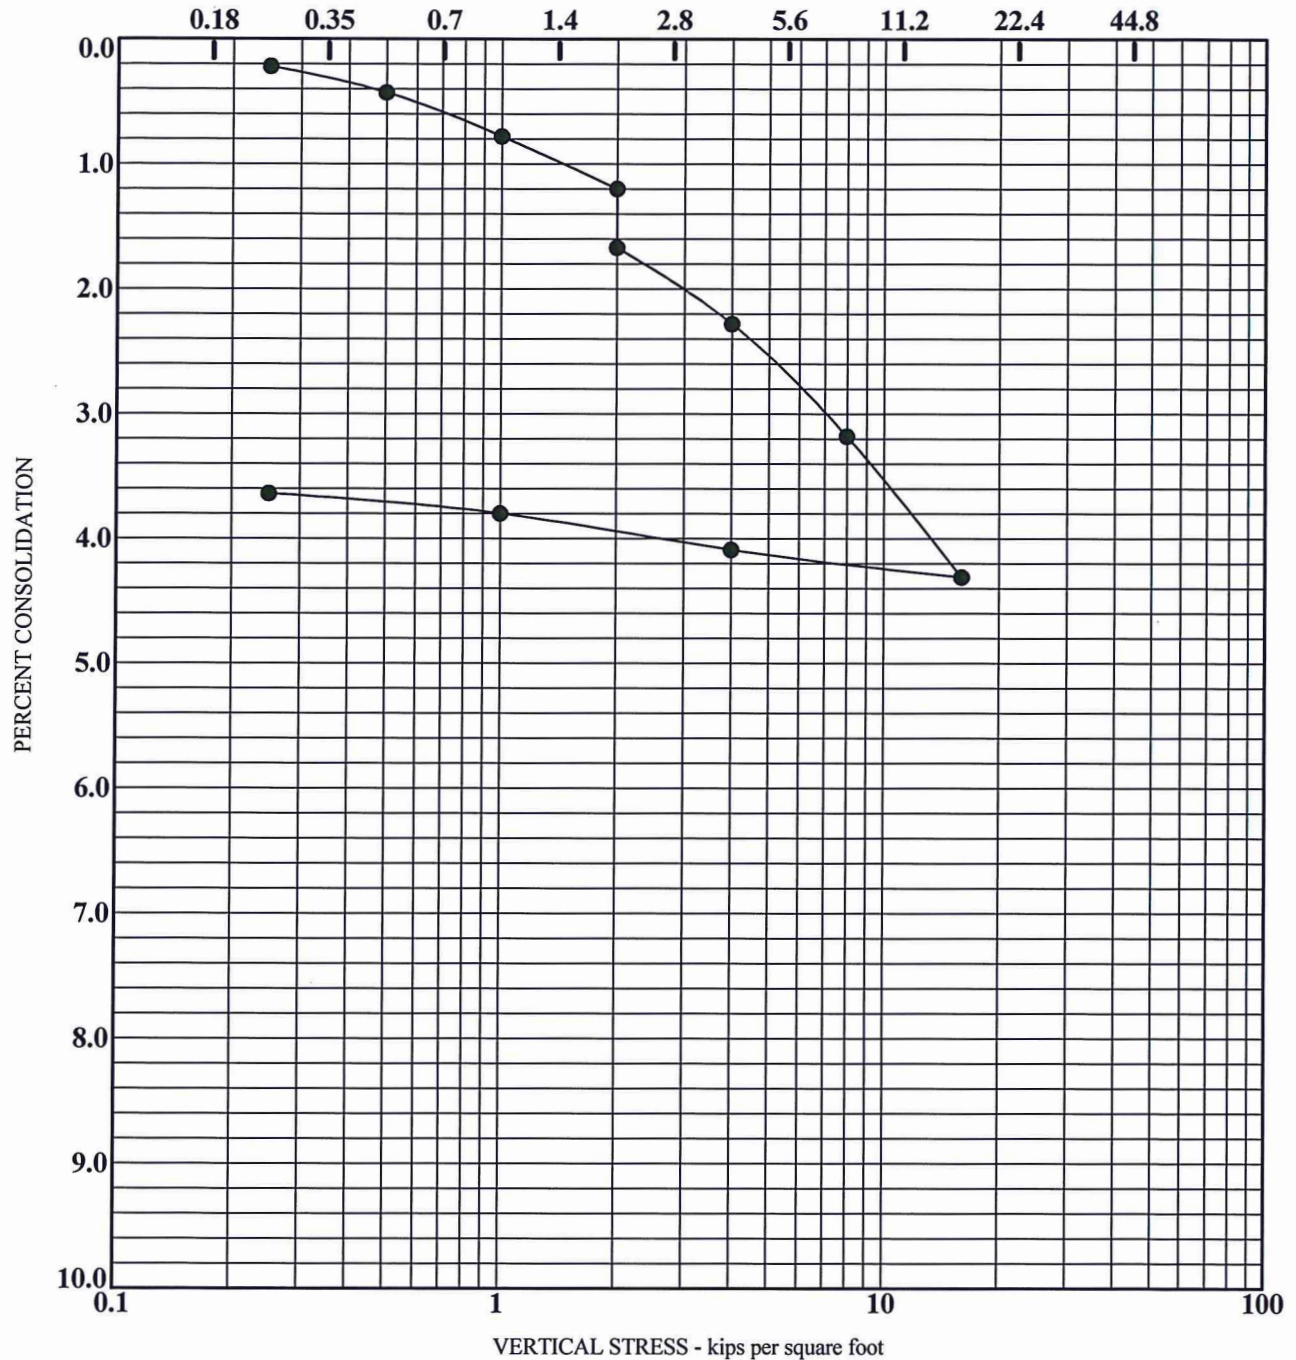
PLATE B-11

SAMPLE LOCATION	MATERIAL DESCRIPTION	INITIAL			INUNDATED
		DENSITY (pcf)	MOISTURE (%)	SATURATION (%)	LOAD (ksf)
● B-1 @ 7.5	Sand (SW) - Fan Deposits	119.4	1.2

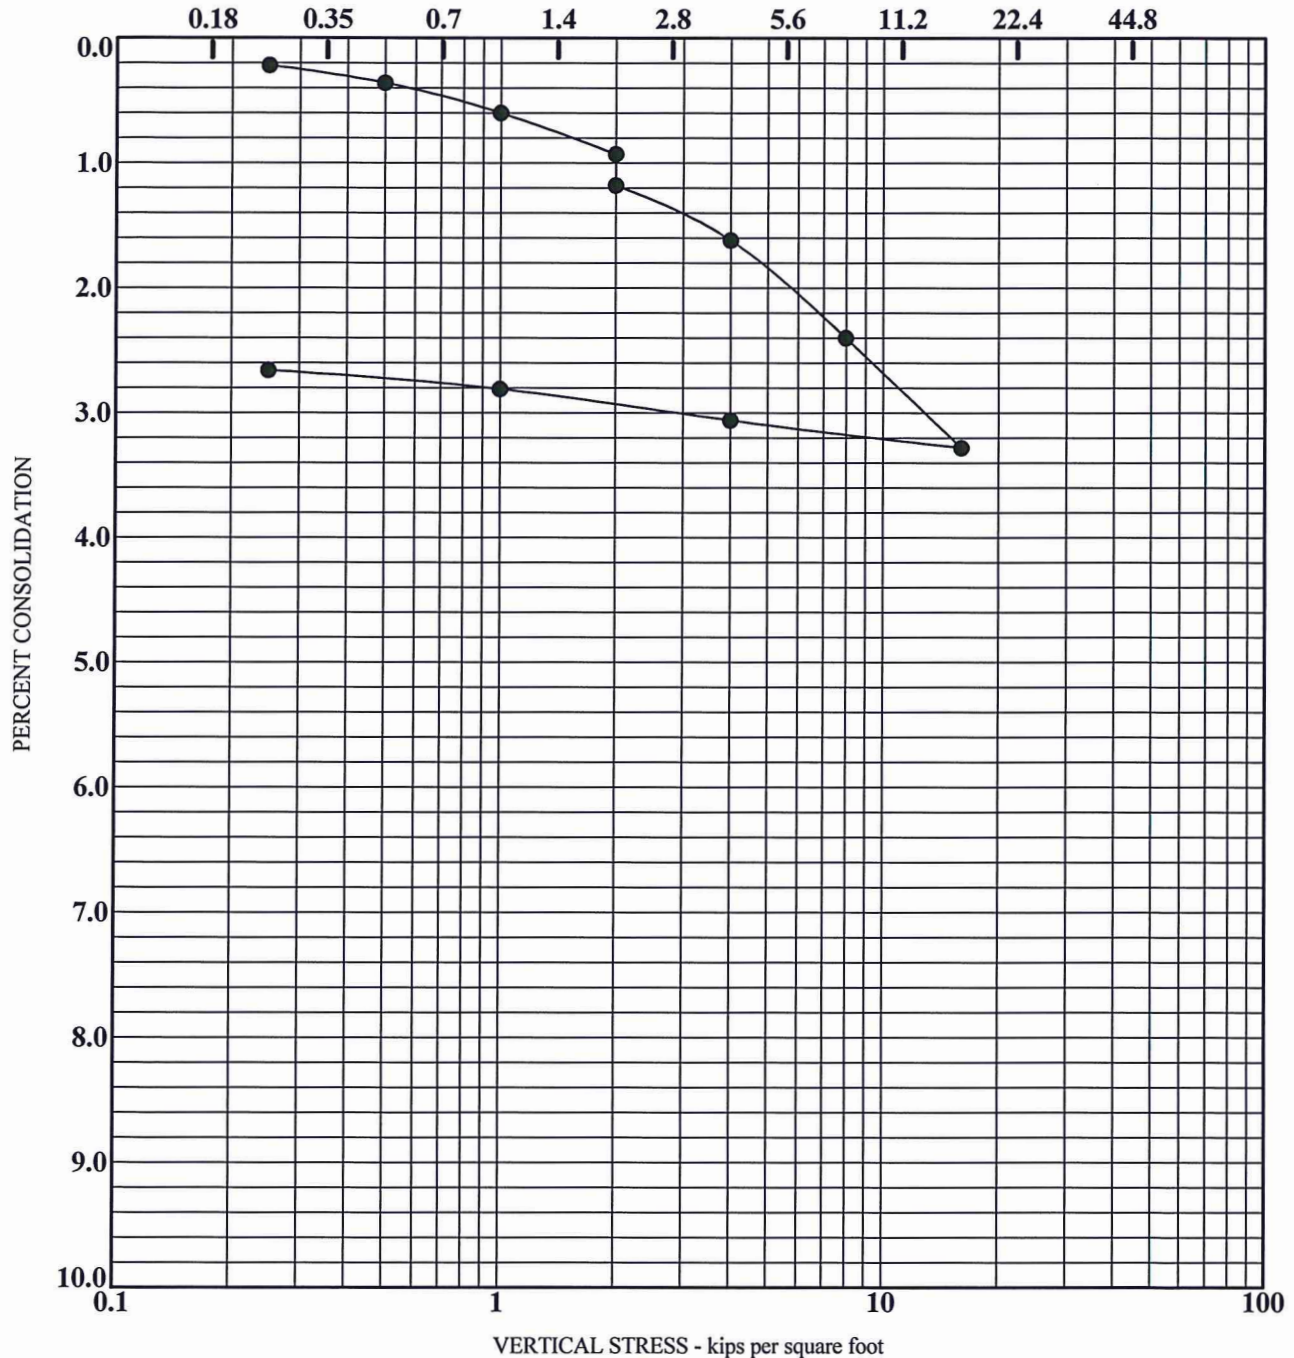
PLATE B-12

SAMPLE LOCATION	MATERIAL DESCRIPTION	INITIAL			INUNDATED
		DENSITY (pcf)	MOISTURE (%)	SATURATION (%)	LOAD (ksf)
● B-2 @ 5.0	Sand (SW-SM) - Fan Deposits	111.3	2.3

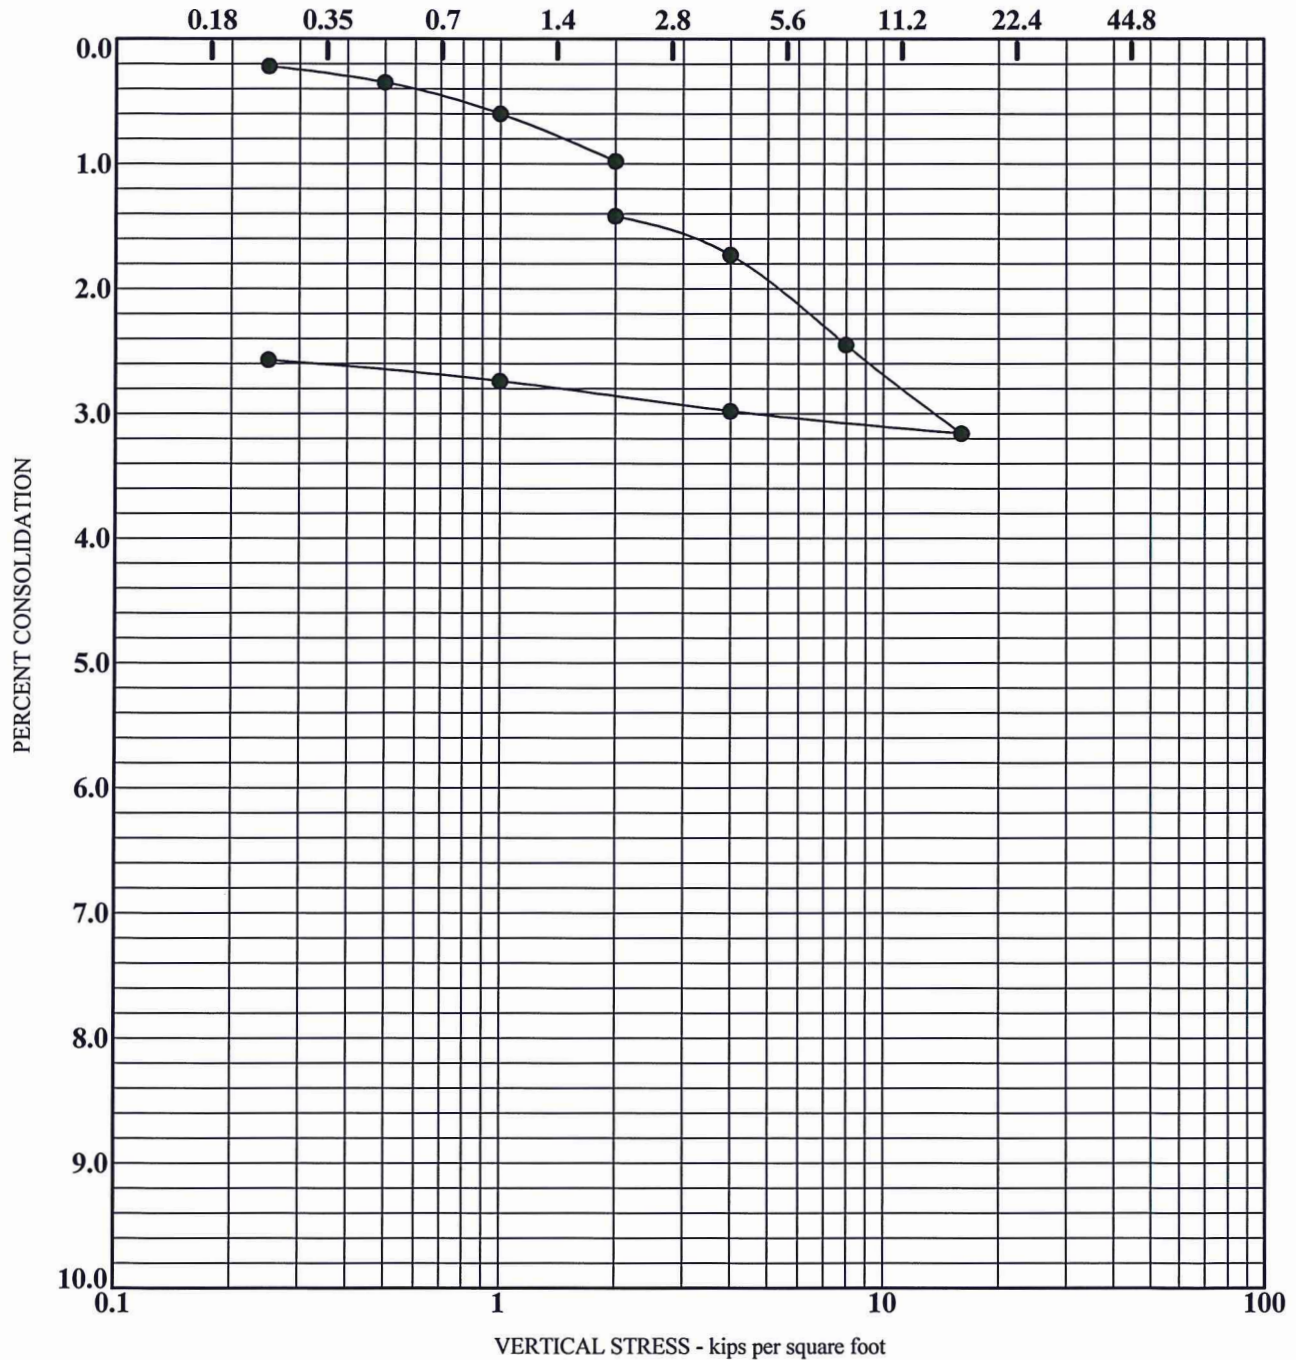
PLATE B-13

SAMPLE LOCATION	MATERIAL DESCRIPTION	INITIAL			INUNDATED
		DENSITY (pcf)	MOISTURE (%)	SATURATION (%)	LOAD (ksf)
● B-3 @ 5.0	Sand (SW) - Fan Deposits	113.1	0.6

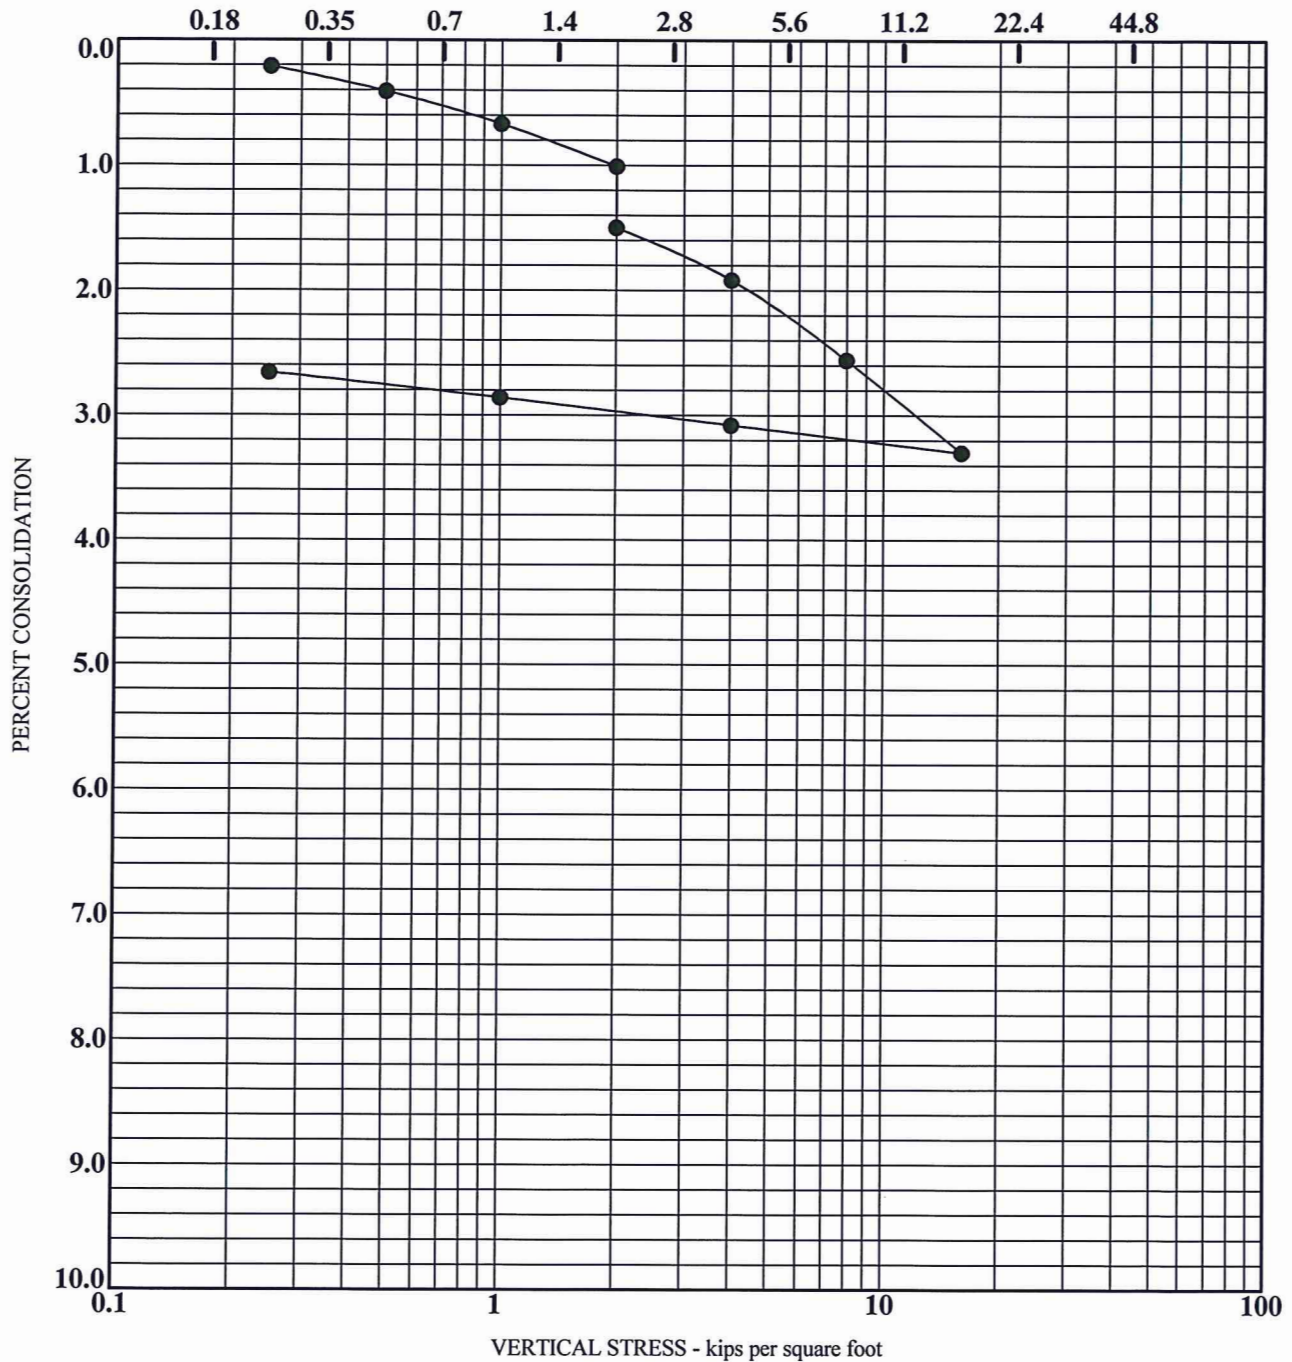
PLATE B-14

SAMPLE LOCATION	MATERIAL DESCRIPTION	INITIAL			INUNDATED
		DENSITY (pcf)	MOISTURE (%)	SATURATION (%)	LOAD (ksf)
● B-4 @ 10.0	Sand (SW-SM) - Fan Deposits	113.9	0.8

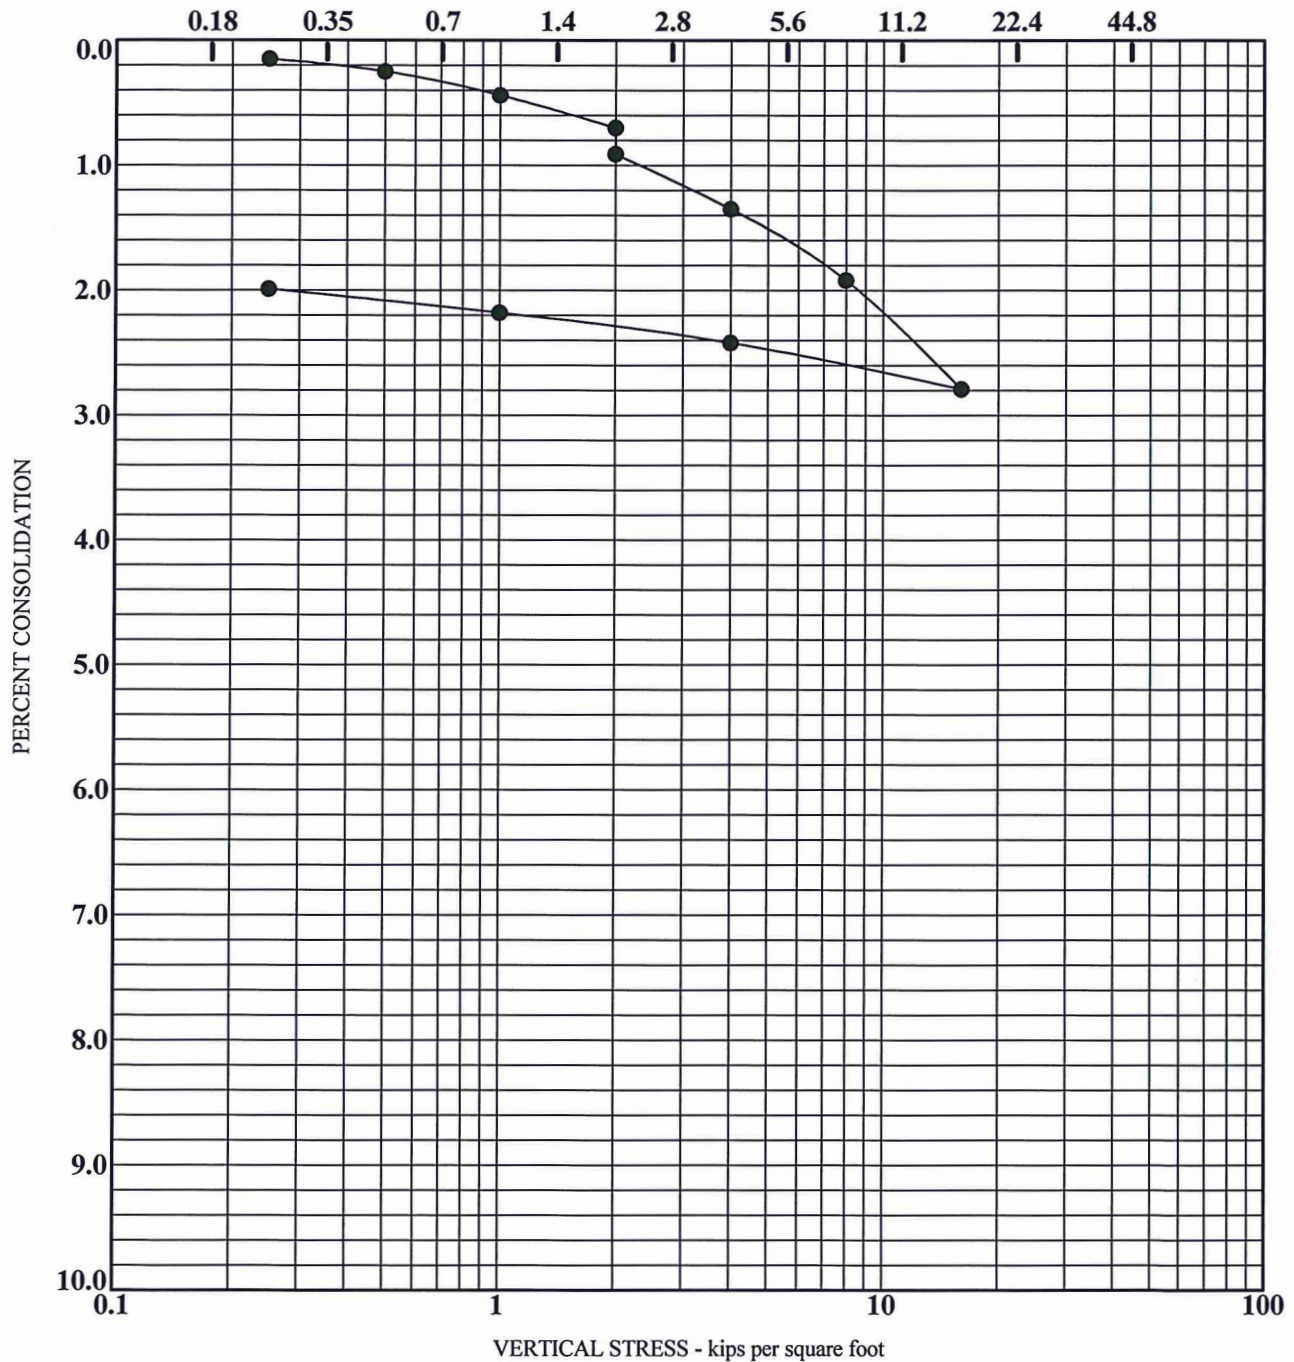
PLATE B-15

SAMPLE LOCATION	MATERIAL DESCRIPTION	INITIAL			INUNDATED
		DENSITY (pcf)	MOISTURE (%)	SATURATION (%)	LOAD (ksf)
● B- 7 @ 5.0	Sand (SW) - Fan Deposits	111.5	0.8

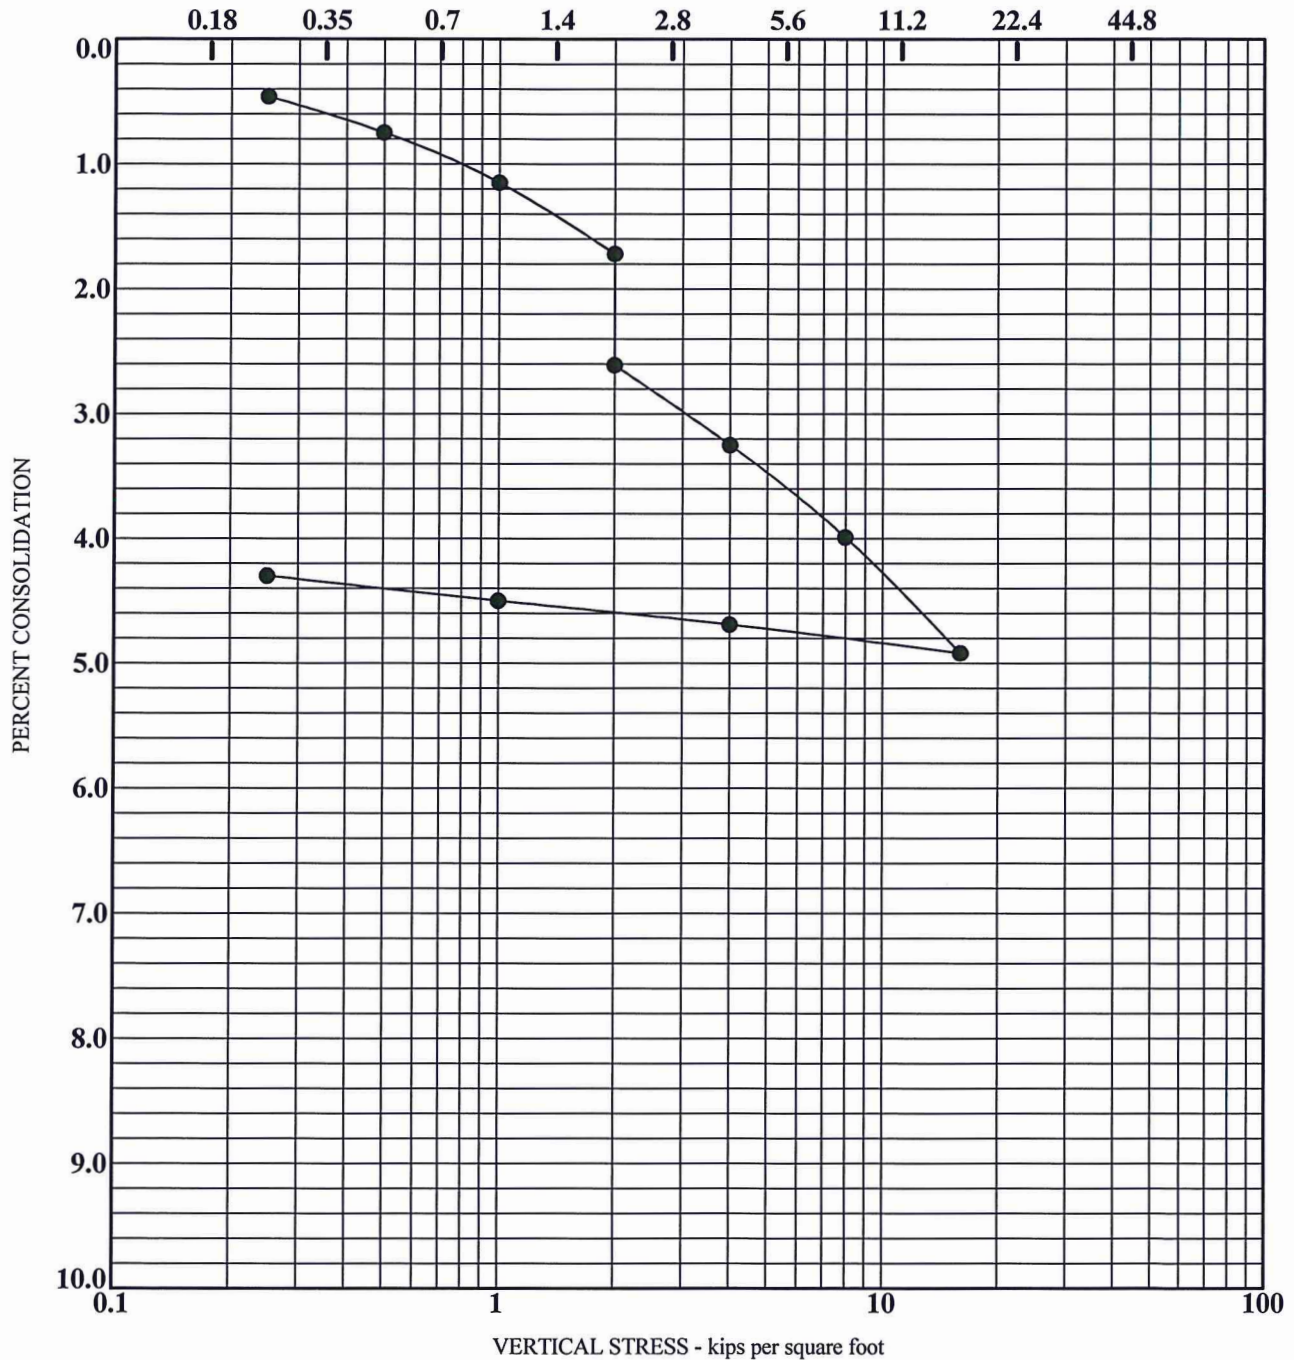
PLATE B-16

SAMPLE LOCATION	MATERIAL DESCRIPTION	INITIAL			INUNDATED
		DENSITY (pcf)	MOISTURE (%)	SATURATION (%)	LOAD (ksf)
● B-17 @ 5.0	Sand (SP) - Ocotillo Fm.	115.6	1.2
