Appendix F1: Feasibility-Level Geotechnical Evaluation

*REVISED FEASIBILITY-LEVEL GEOTECHNICAL EVALUATION
KPC COACHELLA PROJECT
2,850-ACRES± OF VACANT LAND NORTH OF INTERSTATE 10
AND EAST OF THE ALL-AMERICAN CANAL
CITY OF COACHELLA, RIVERSIDE COUNTY, CALIFORNIA*

*March 23, 2023
J.N. 16-368
Revision 2*

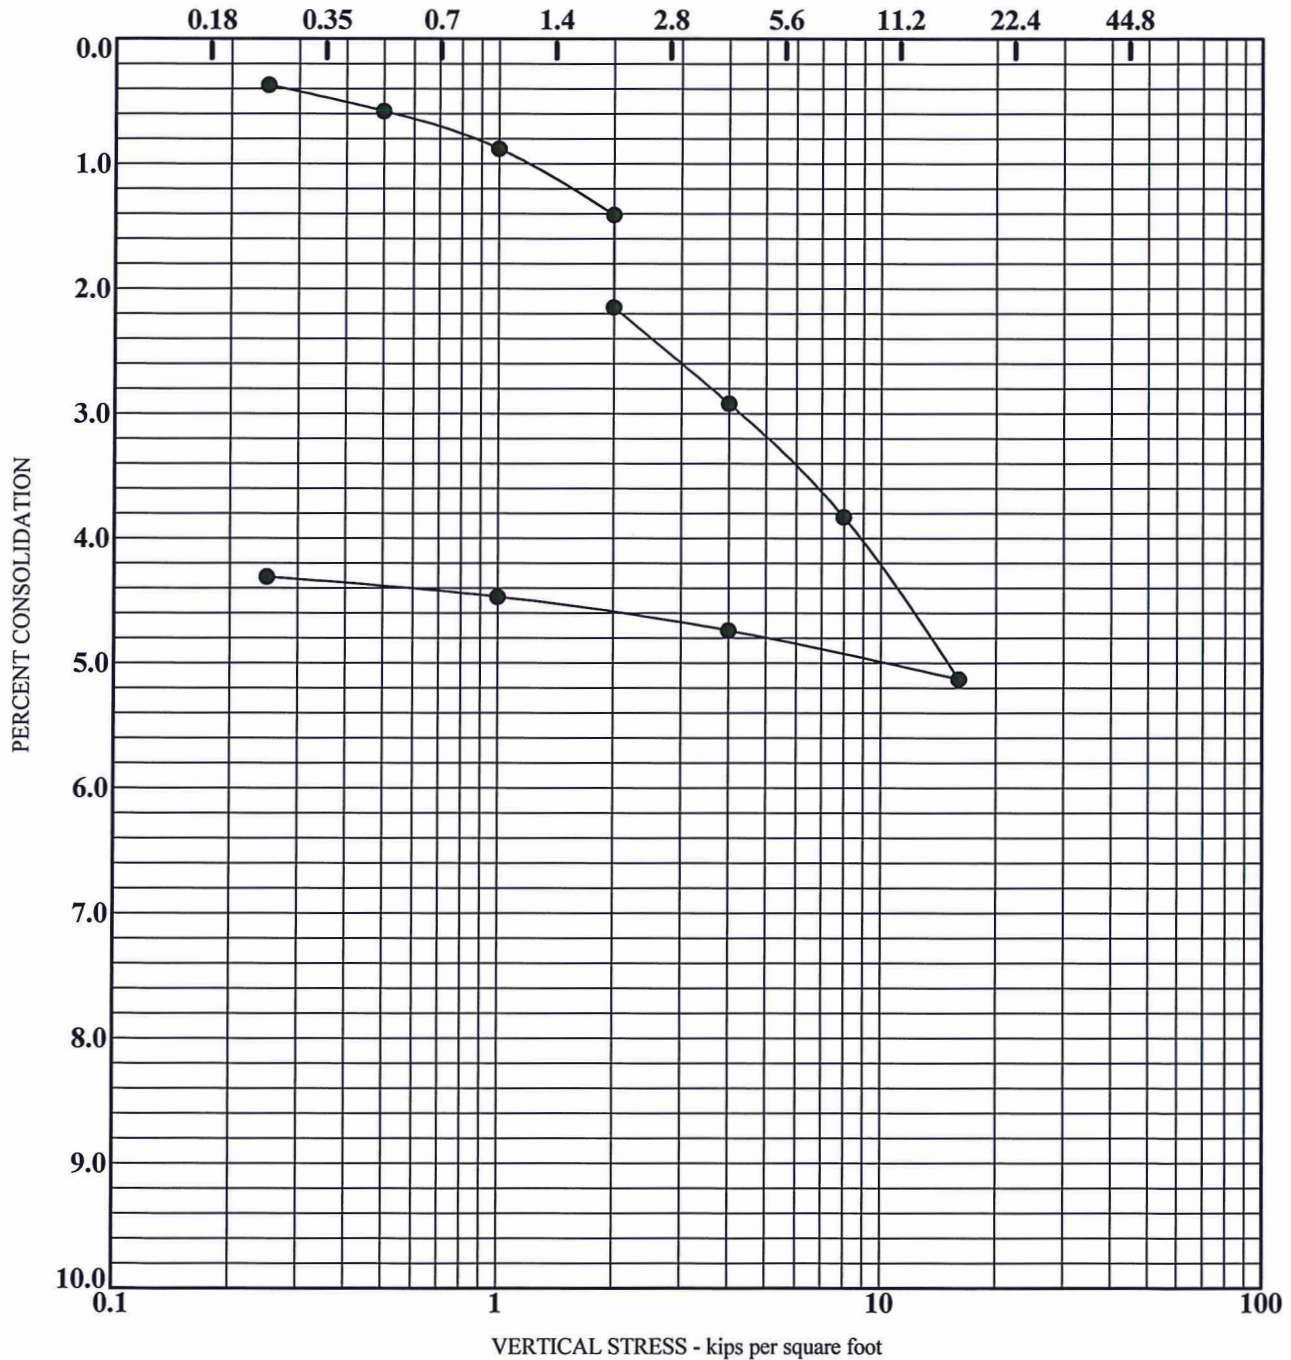
PLATE B-17

SAMPLE LOCATION	MATERIAL DESCRIPTION	INITIAL			INUNDATED
		DENSITY (pcf)	MOISTURE (%)	SATURATION (%)	LOAD (ksf)
● B-18 @ 10.0	Silty Sand (SM) - Ocotillo Conglomerate		1.4

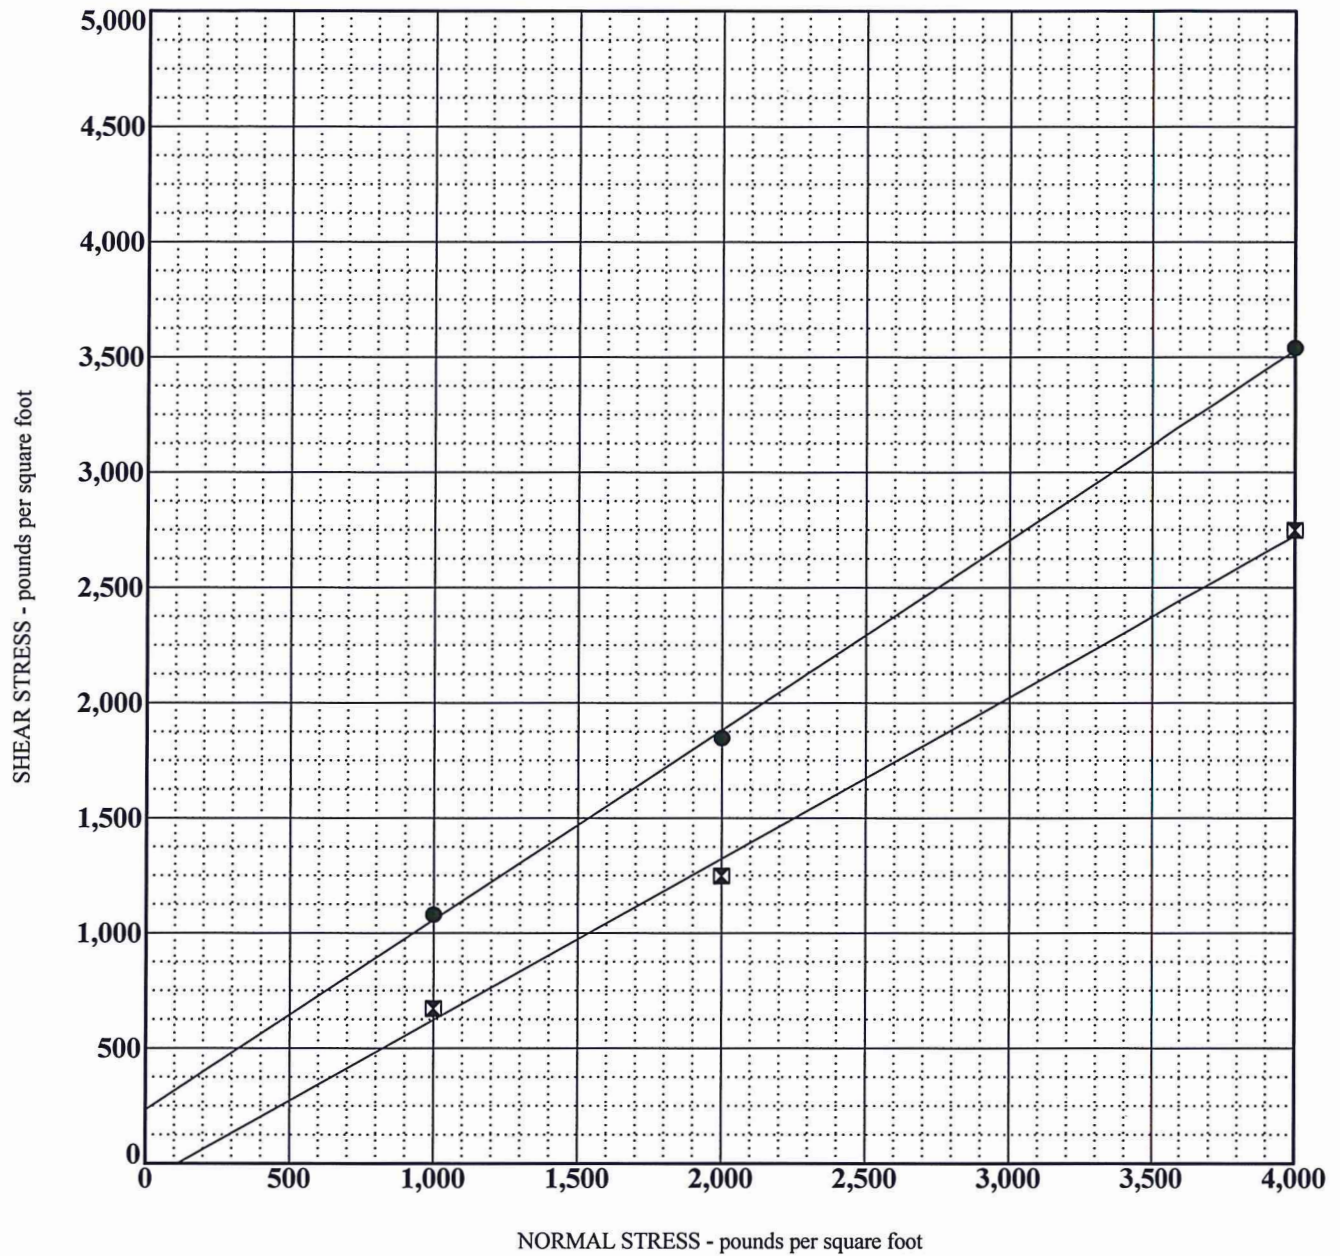
PLATE B-18

SAMPLE LOCATION	DESCRIPTION	FRICTION ANGLE (°)	COHESION (PSF)
● B- 1 @ 0.0	Sand (SW) - Fan Deposits - Peak	39	230
☒ B- 1 @ 0.0	Sand (SW) - Fan Deposits - Ultimate	35	0

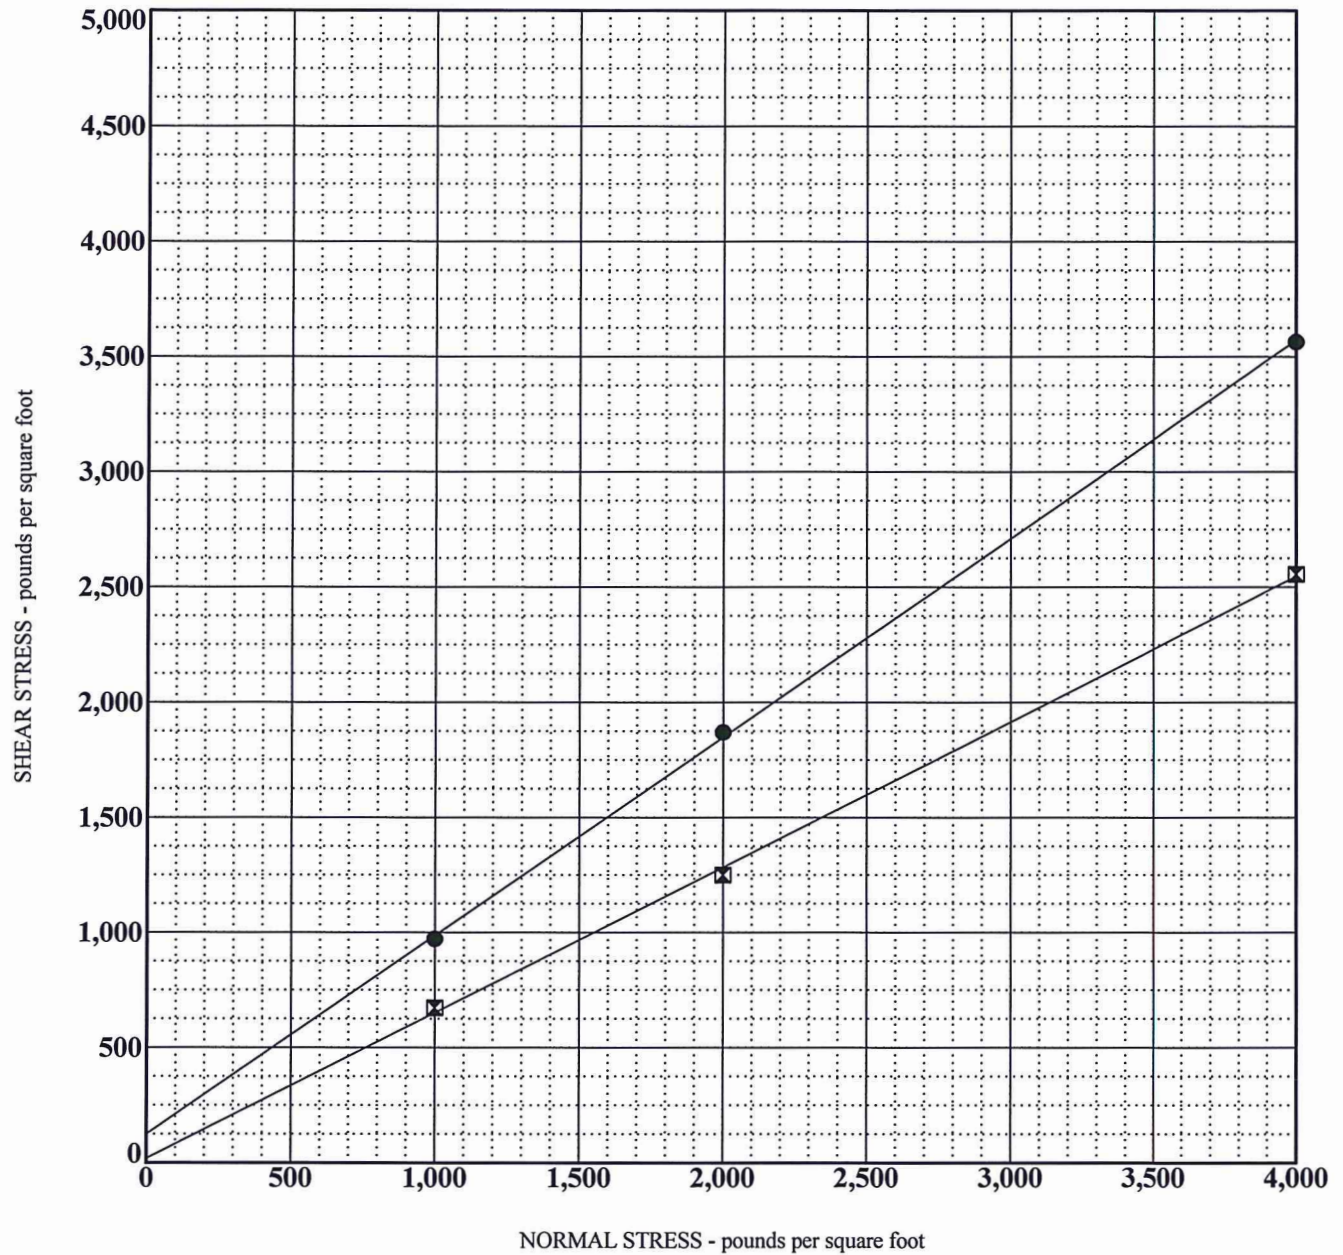
PLATE B-19

SAMPLE LOCATION	DESCRIPTION	FRICTION ANGLE (°)	COHESION (PSF)
● B- 2 @ 0.0	Sand (SW-SM) - Fan Deposits - Peak	41	125
☒ B- 2 @ 0.0	Sand (SW-SM) - Fan Deposits - Ultimate	32	20

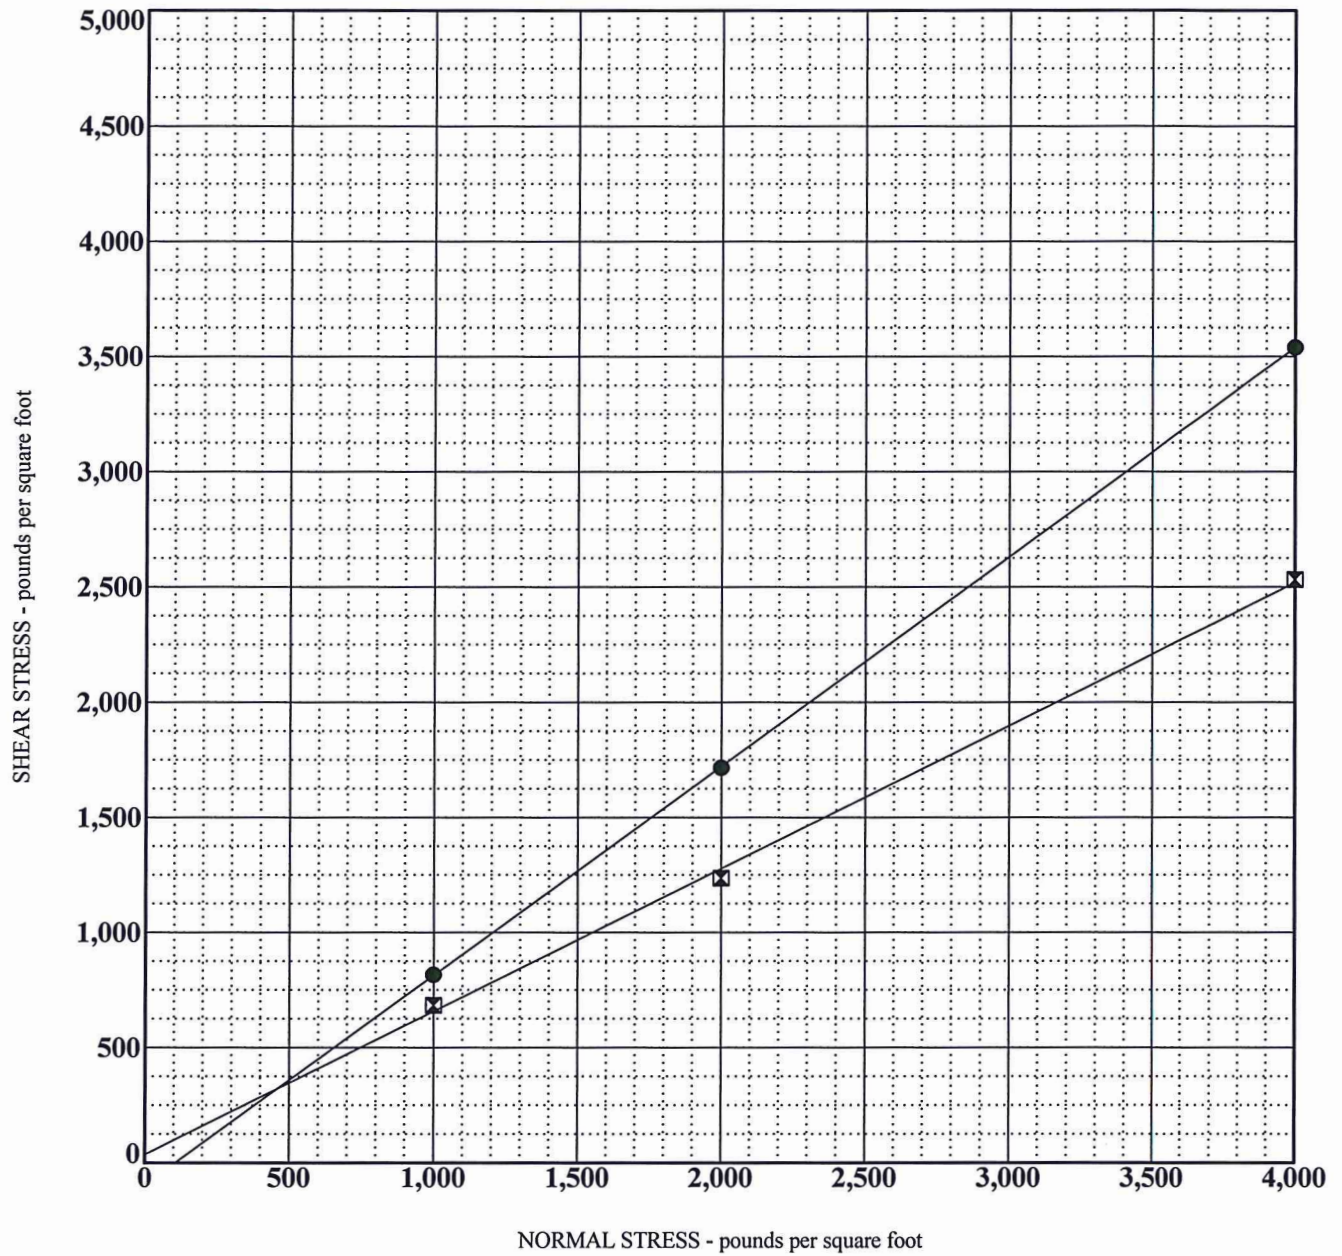
PLATE B-20

SAMPLE LOCATION	DESCRIPTION	FRICTION ANGLE (°)	COHESION (PSF)
● B- 2 @ 15.0	Silty Sand (SM) Palm Spring Fm - Peak	42	0
☒ B- 2 @ 15.0	Silty Sand (SM) Palm Spring Fm - Ultimate	32	40

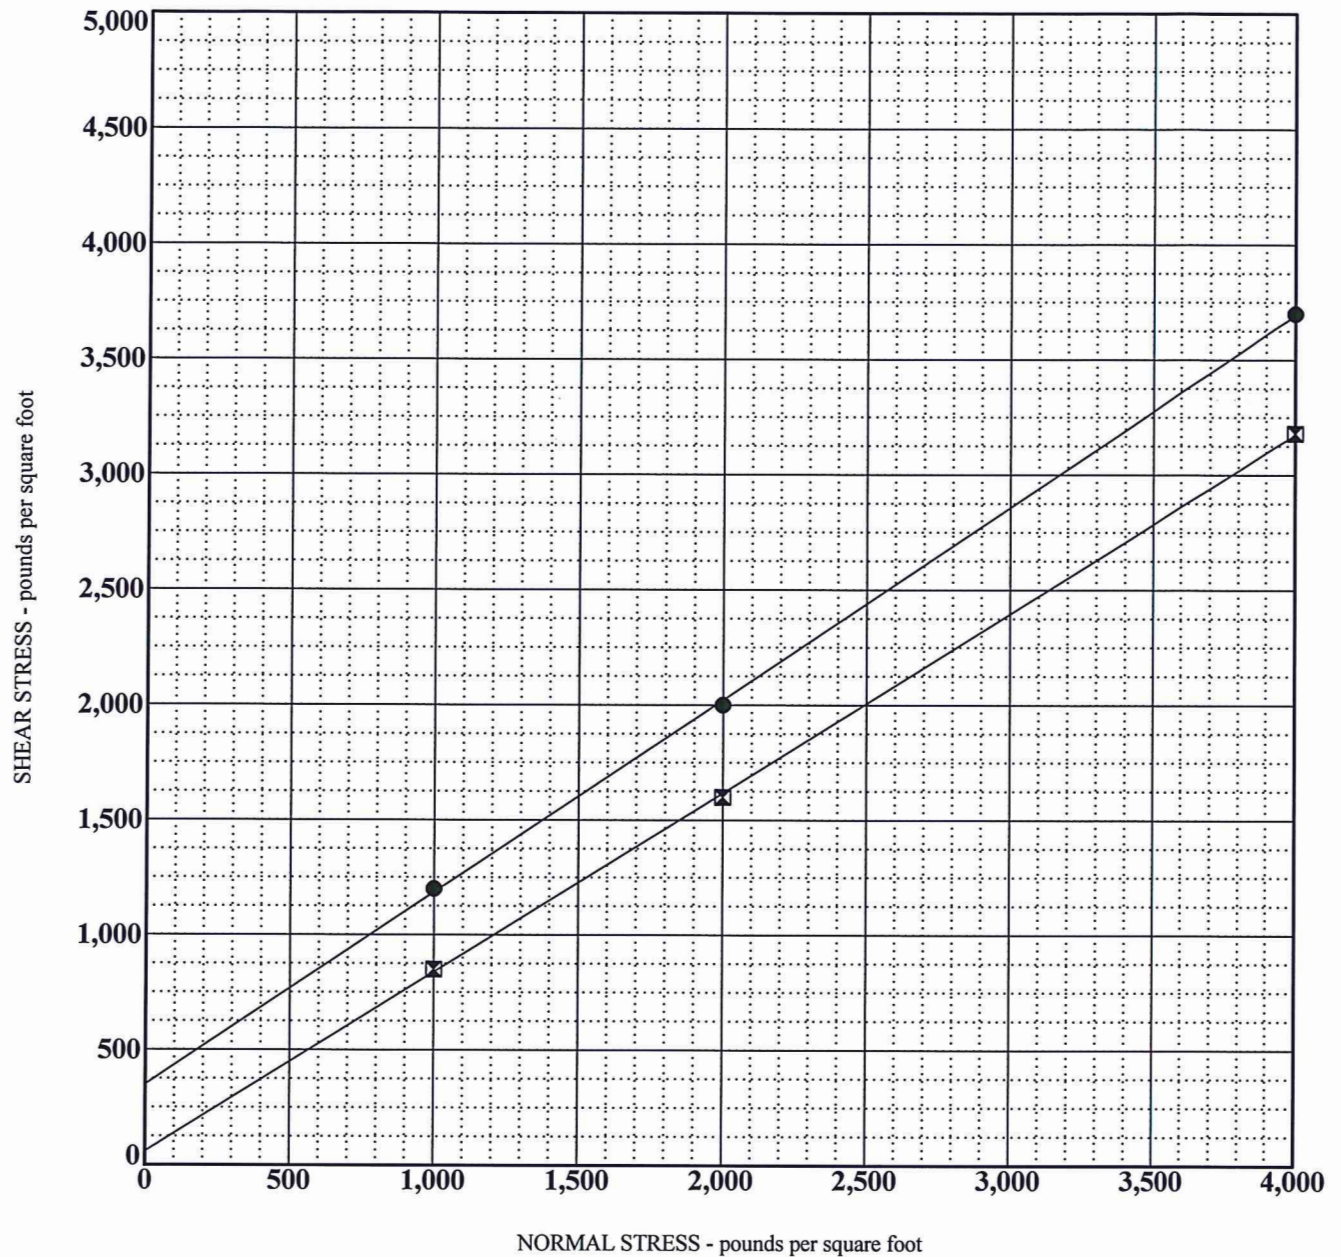
PLATE B-21

SAMPLE LOCATION	DESCRIPTION	FRICTION ANGLE (°)	COHESION (PSF)
● B- 3 @ 10.0	Sand (SW) - Fan Deposits - Peak	40	350
☐ B- 3 @ 10.0	Sand (SW) - Fan Deposits - Ultimate	38	60

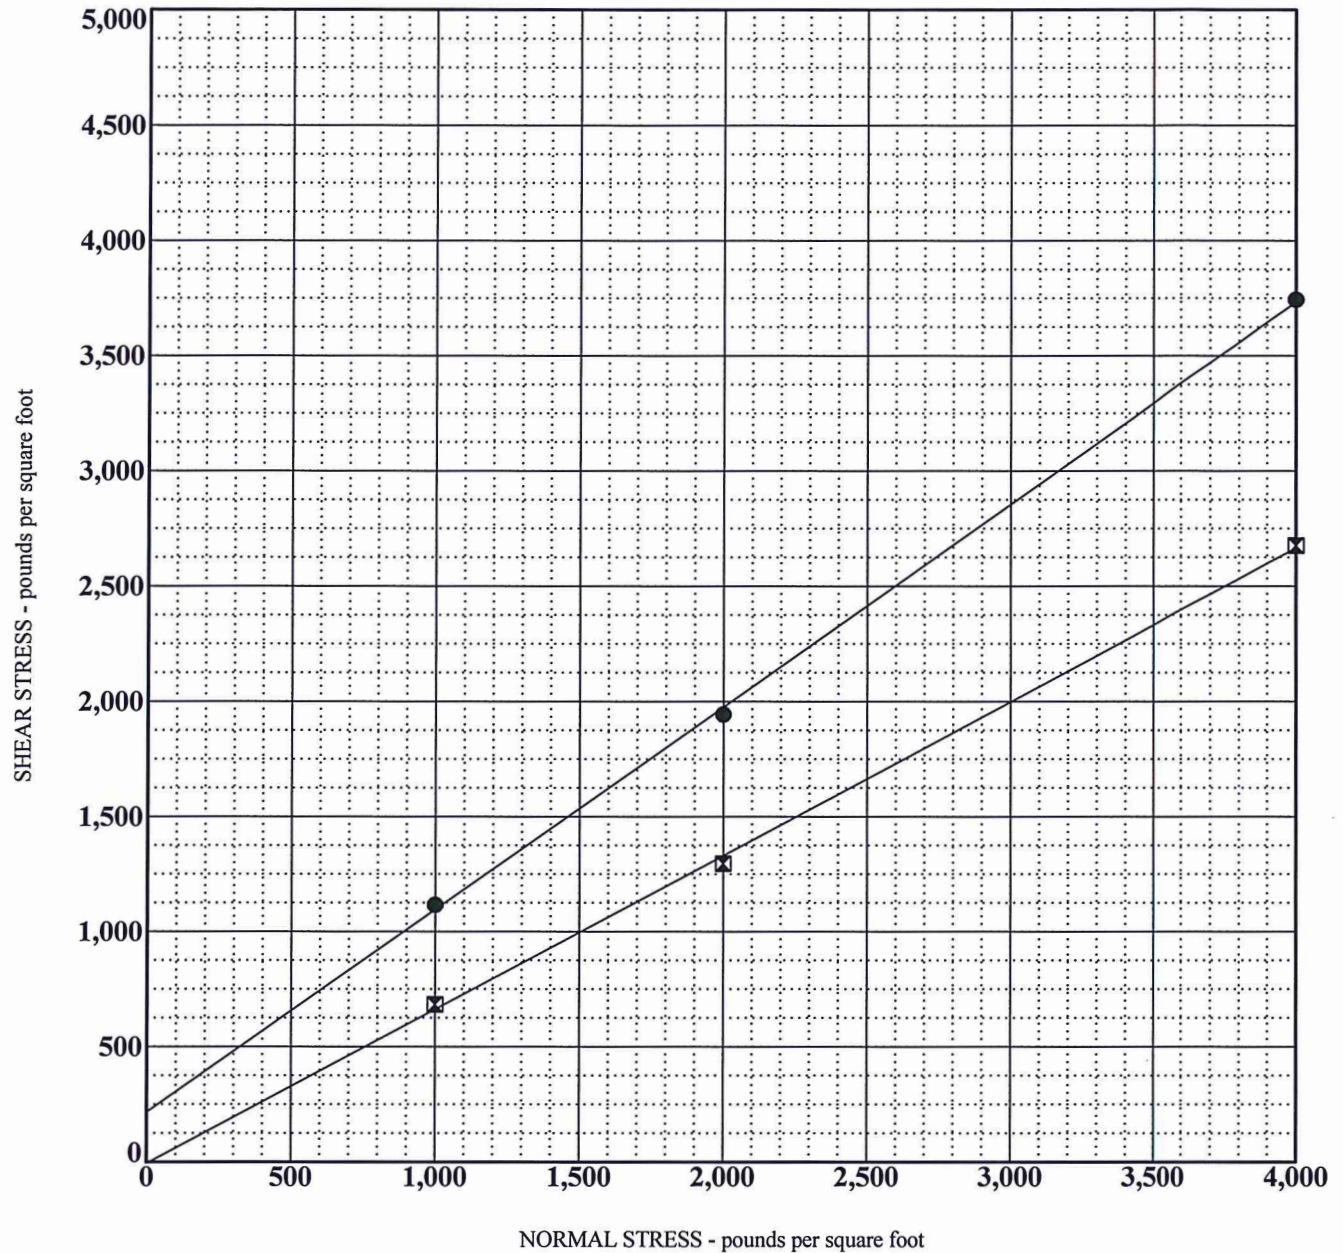
PLATE B-22

SAMPLE LOCATION	DESCRIPTION	FRICTION ANGLE (°)	COHESION (PSF)
● B- 6 @ 0.0	Sand (SW-SM) - Fan Deposits - Peak	41	220
✕ B- 6 @ 0.0	Sand (SW-SM) - Fan Deposits - Ultimate	34	0

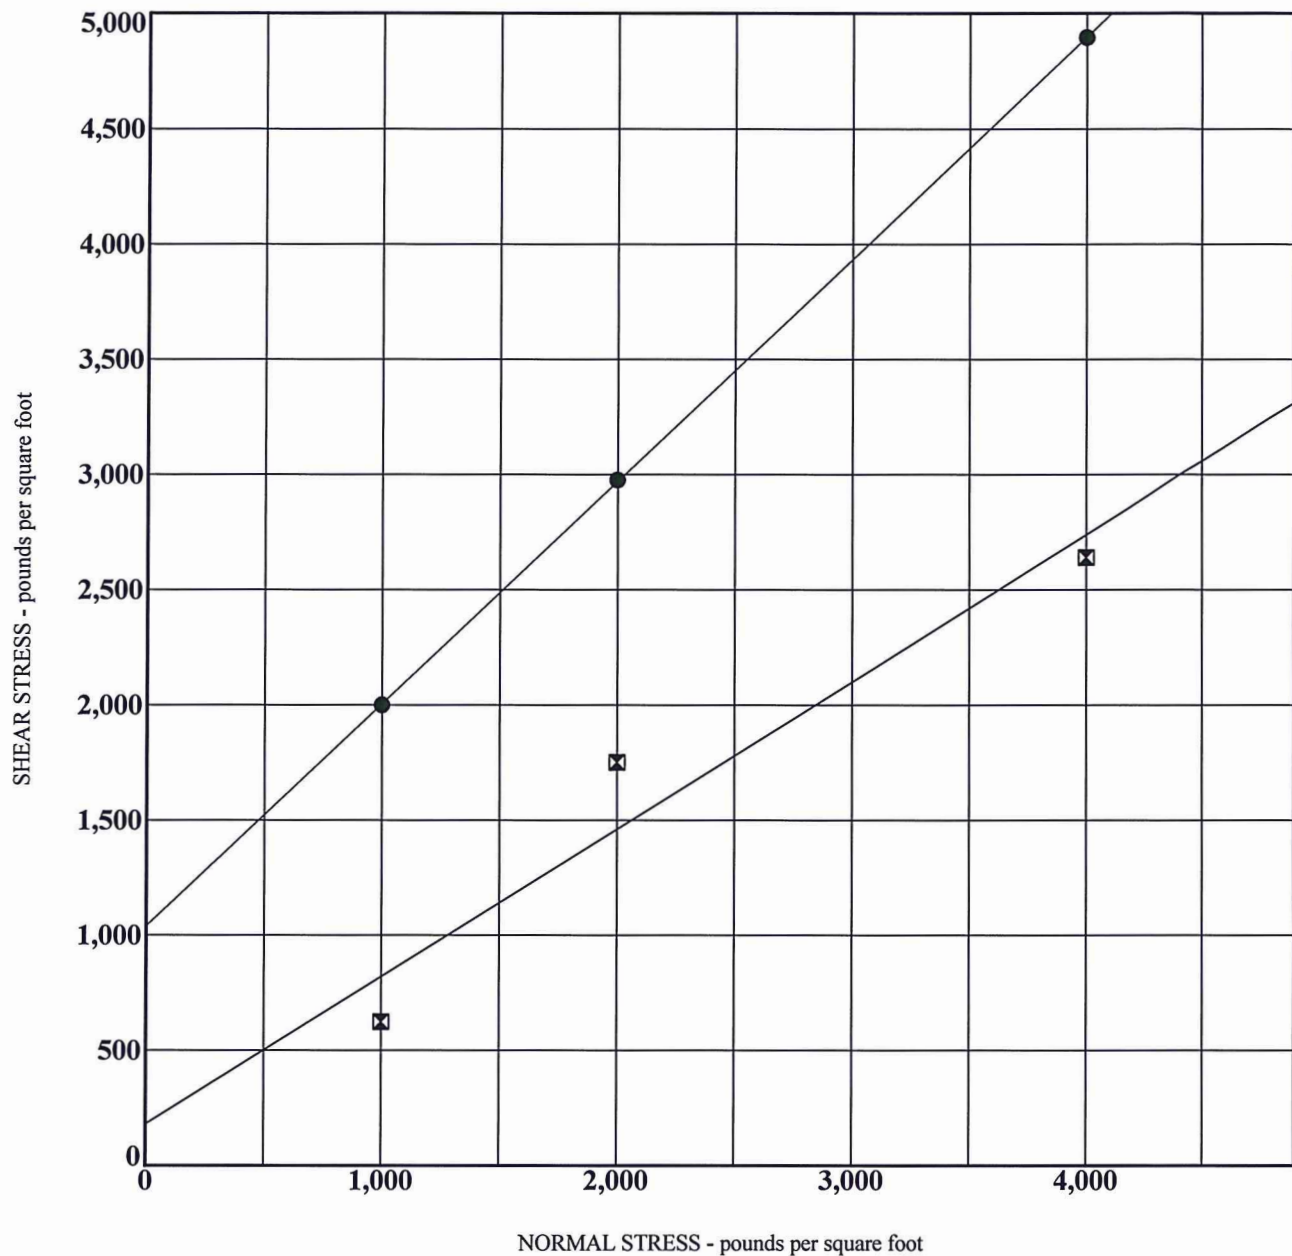
SAMPLE LOCATION	DESCRIPTION	FRICTION ANGLE (°)	COHESION (PSF)
● B- 9 @ 30.0	Sandy Silt (ML) - Palm Spring Fm. - Peak	44	1040
☒ B- 9 @ 30.0	Sandy Silt (ML) - Palm Spring Fm. - Ultimate	33	180

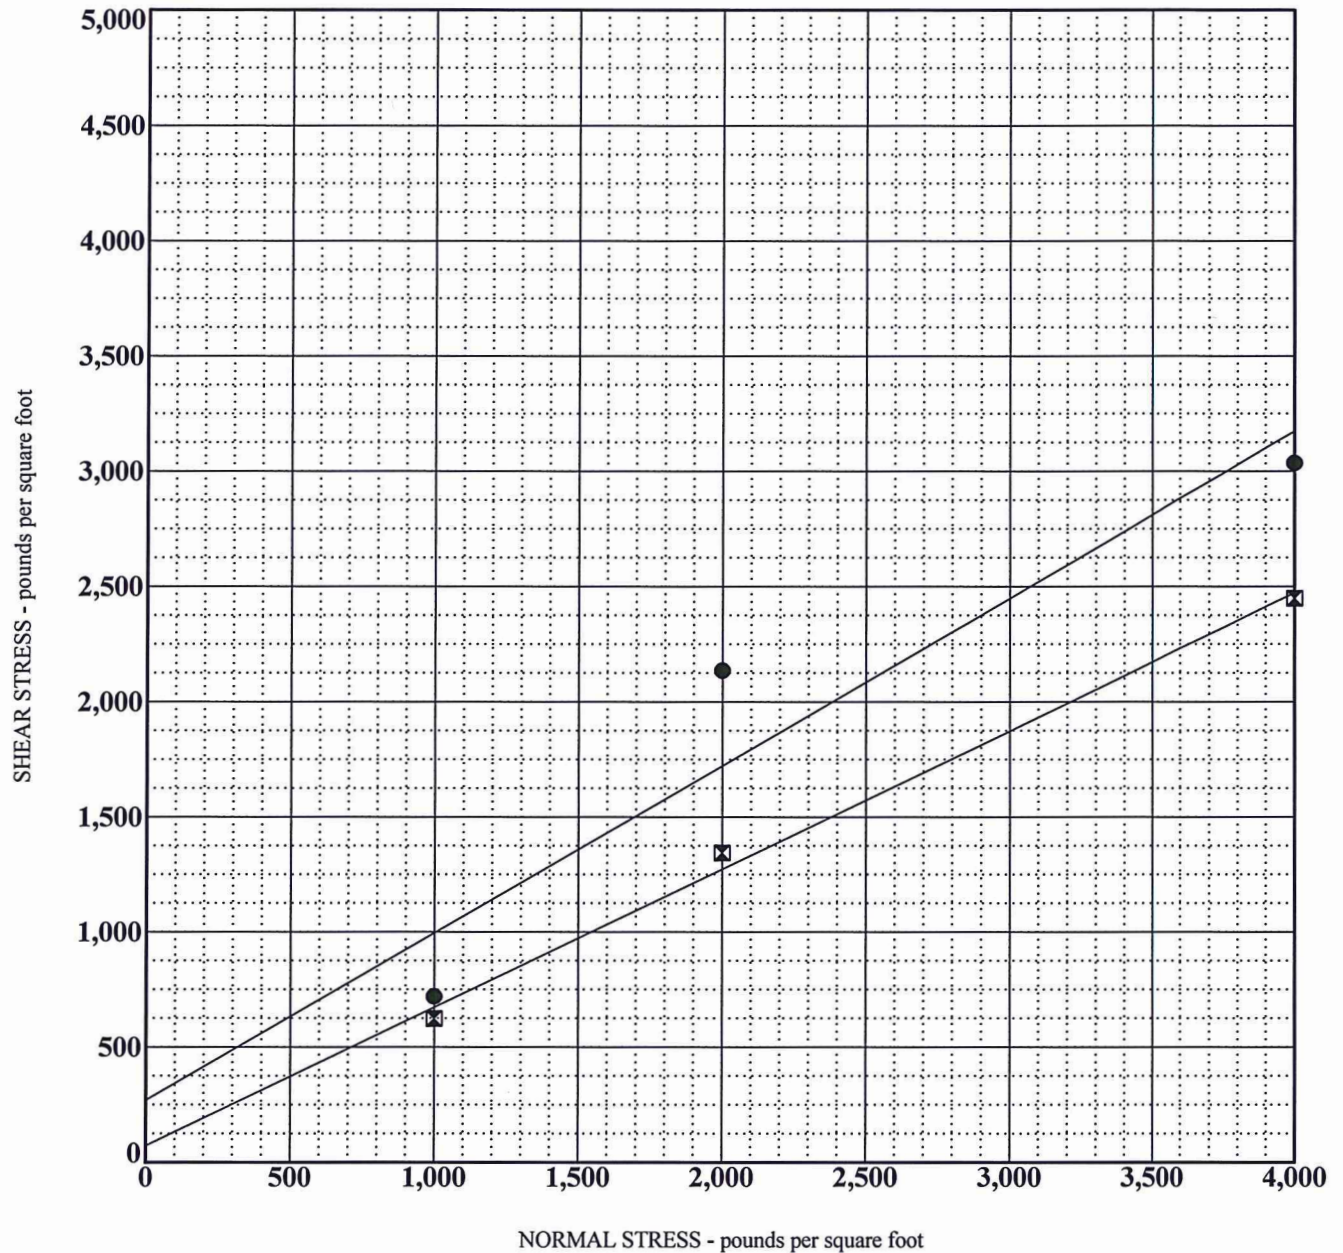
PLATE B-23

SAMPLE LOCATION	DESCRIPTION	FRICTION ANGLE (°)	COHESION (PSF)
● B-12 @ 15.0	Sandy Silt (ML) - Palm Spring Fm - Peak	36	270
☒ B-12 @ 15.0	Sandy Silt (ML) - Palm Spring Fm - Ultimate	31	70

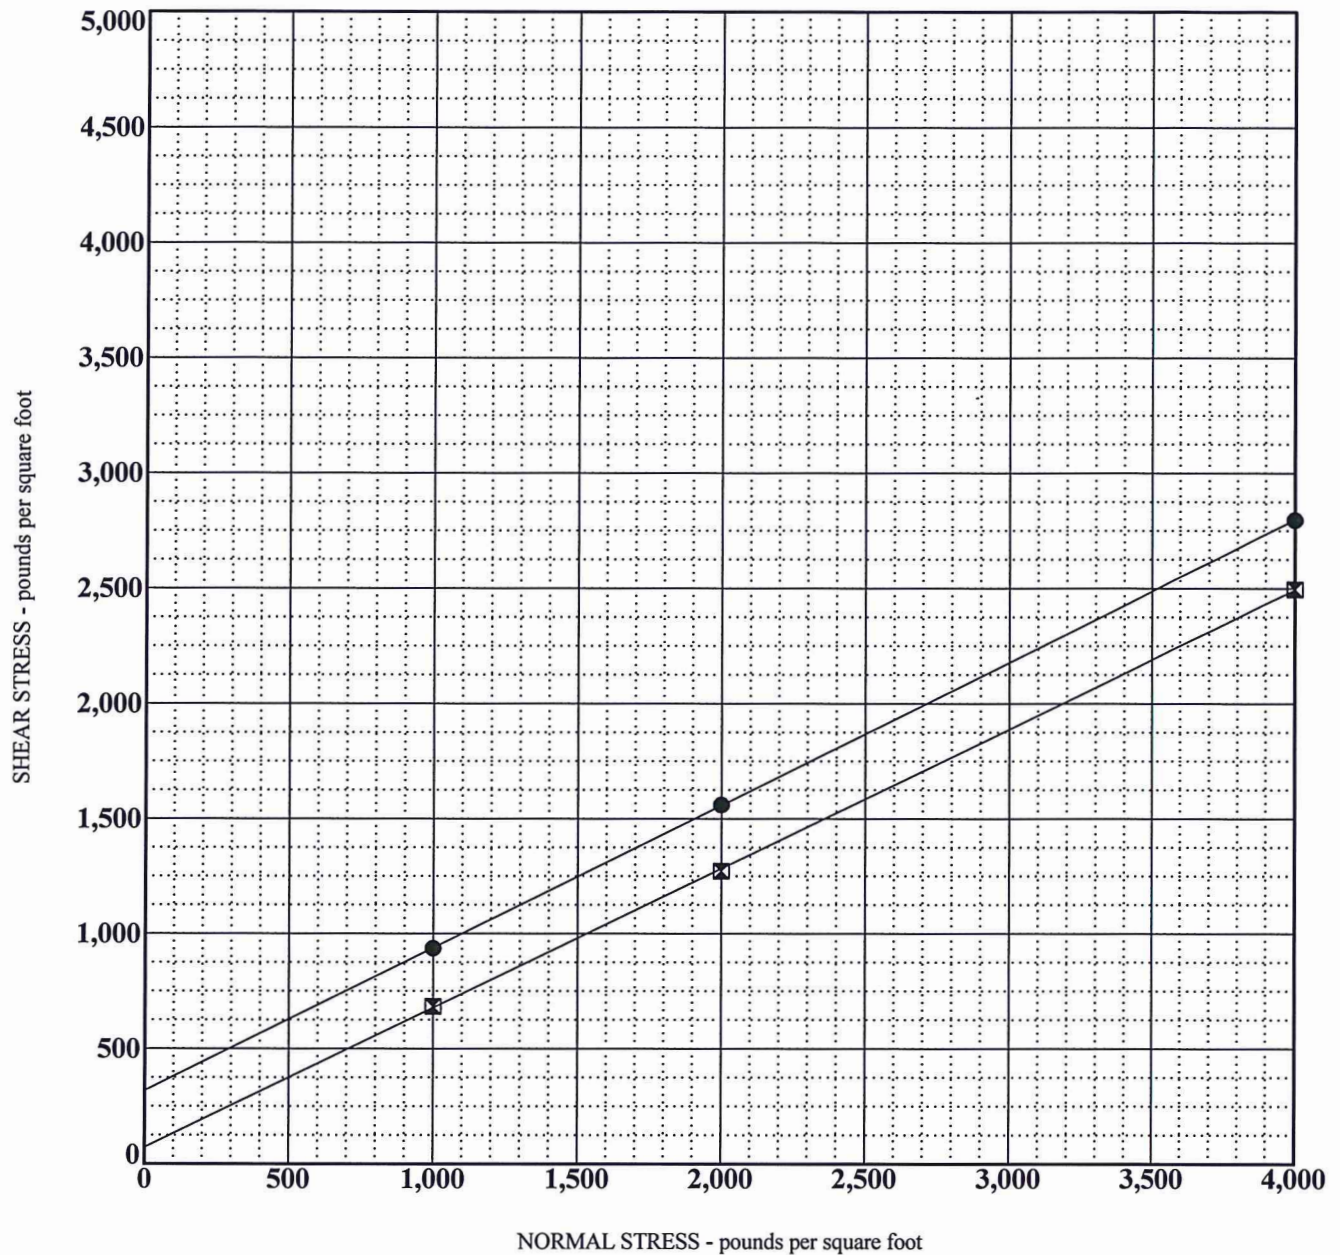
PLATE B-24

SAMPLE LOCATION	DESCRIPTION	FRICTION ANGLE (°)	COHESION (PSF)
● B-13 @ 0.0	Sandy Silt (ML) Palm Spring FM - Peak	32	320
☒ B-13 @ 0.0	Sandy Silt (ML) Palm Spring FM - Ultimate	31	70

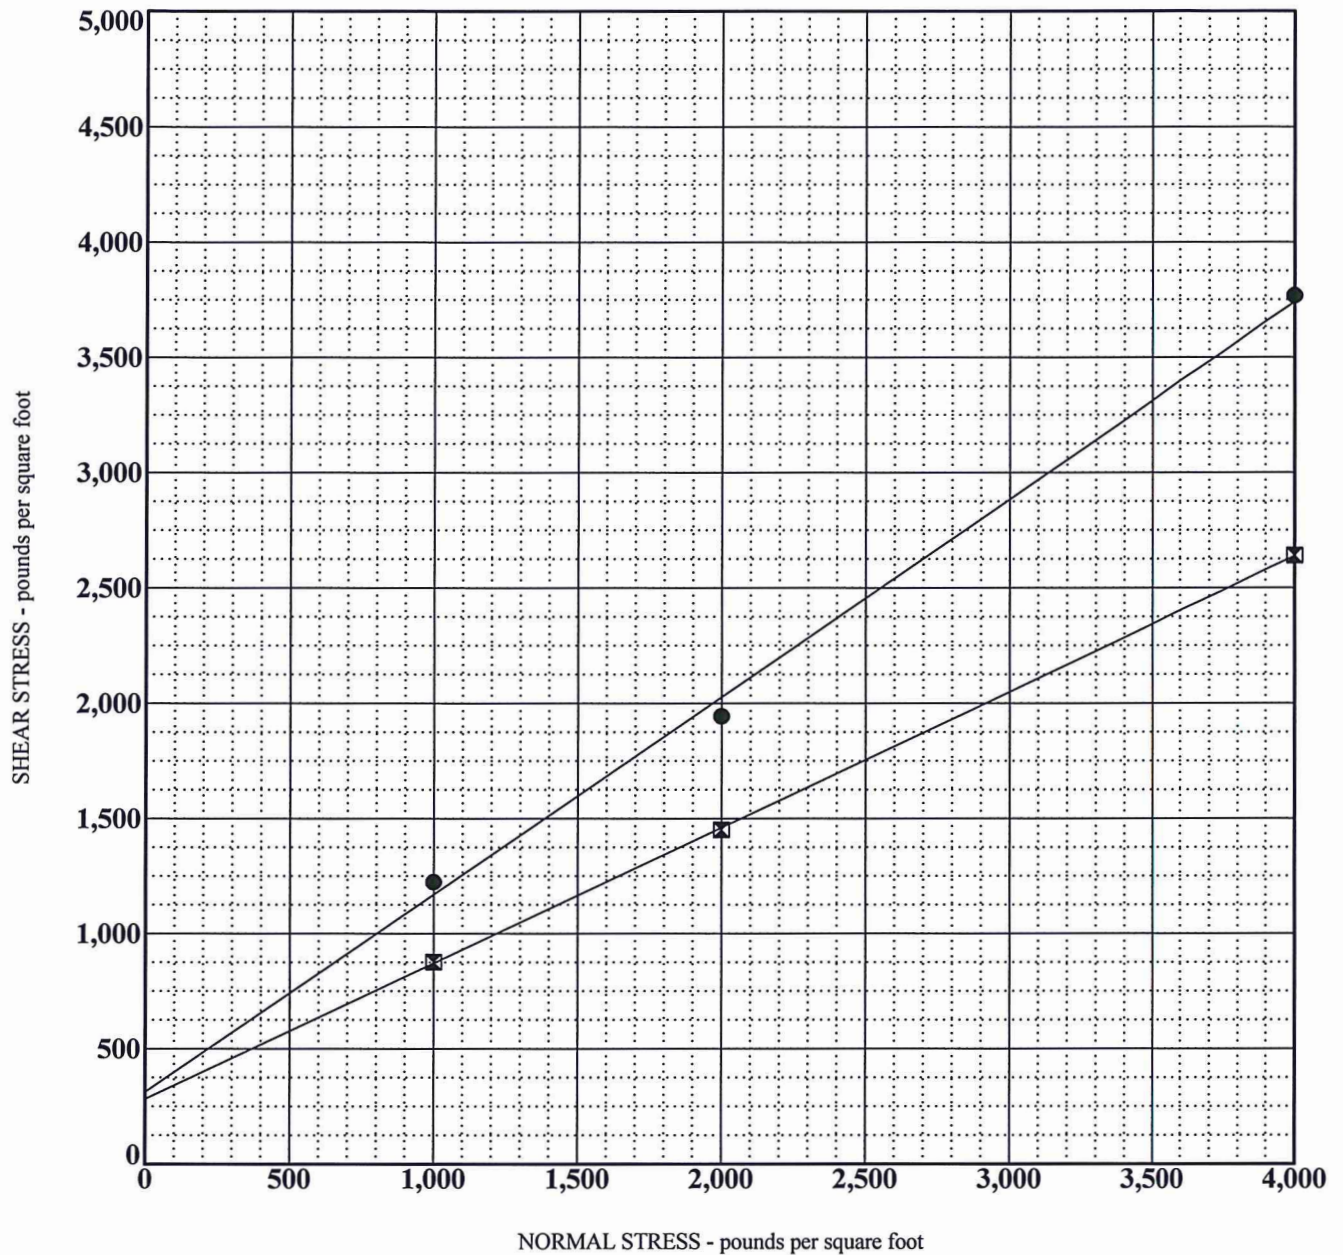
PLATE B-25

SAMPLE LOCATION	DESCRIPTION	FRICTION ANGLE (°)	COHESION (PSF)
● B-14 @ 5.0	Sand (SW) - Fan Deposits - Peak	41	310
☒ B-14 @ 5.0	Sand (SW) - Fan Deposits - Ultimate	30	280

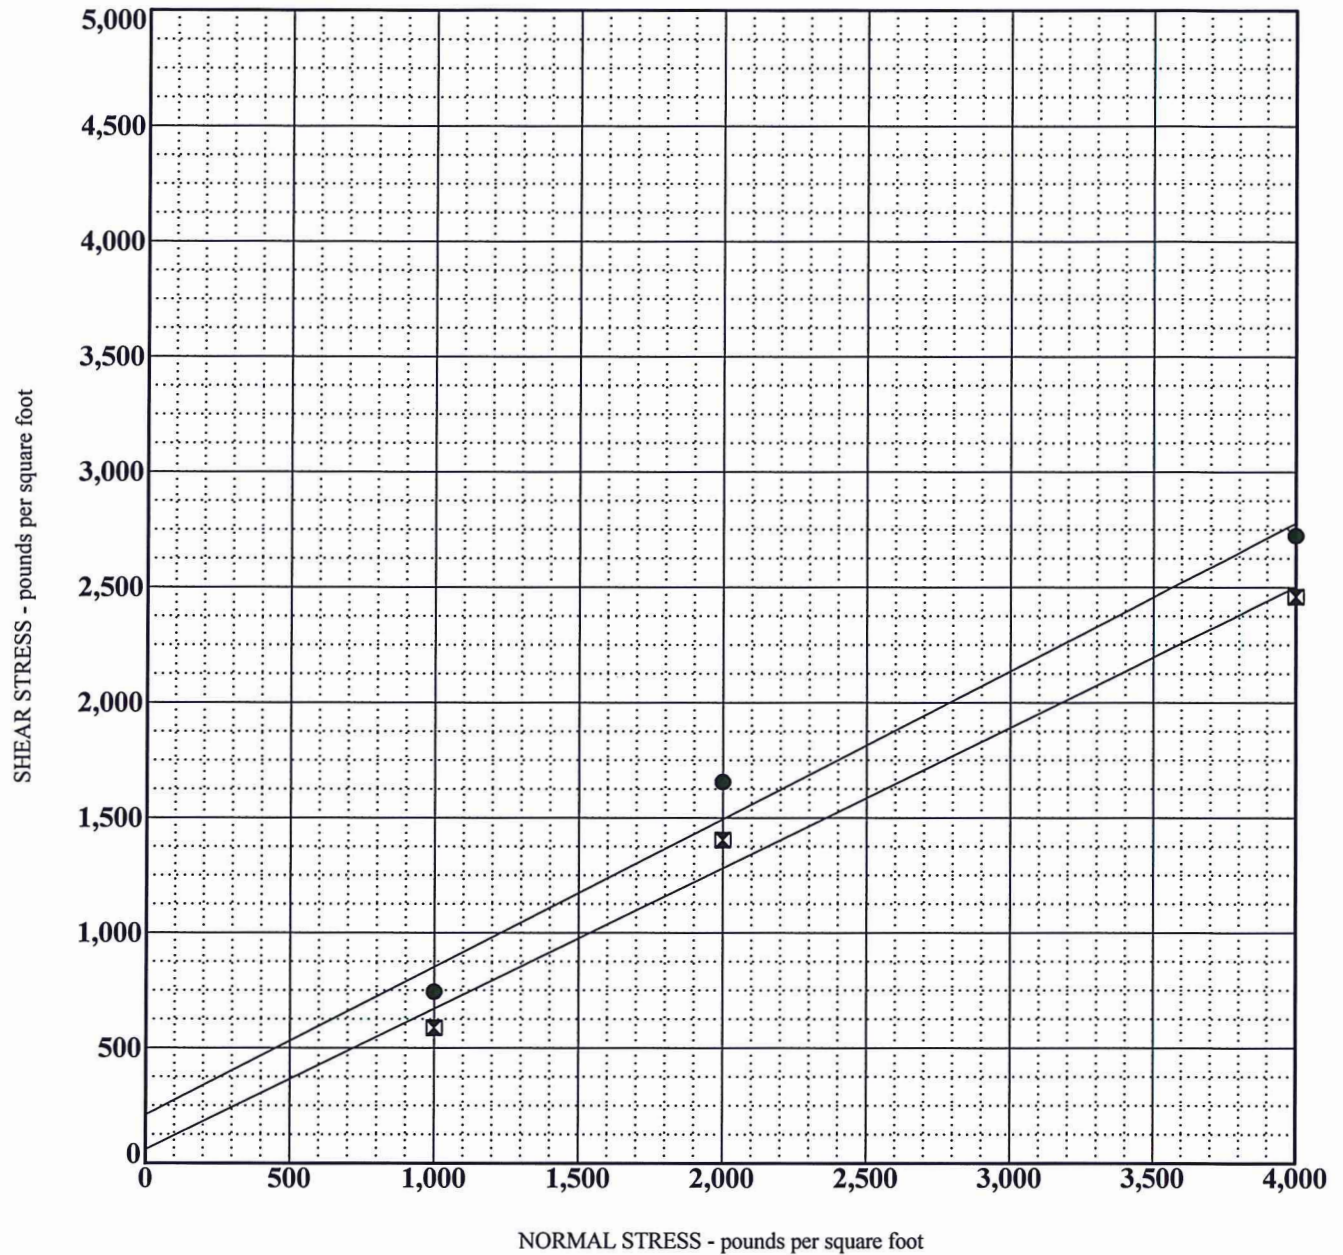
PLATE B-26

SAMPLE LOCATION	DESCRIPTION	FRICTION ANGLE (°)	COHESION (PSF)
● B-16 @ 15.0	Sandy Silt (ML) - Palm Spring Fm - Peak	33	210
☒ B-16 @ 15.0	Sandy Silt (ML) - Palm Spring Fm - Ultimate	32	60

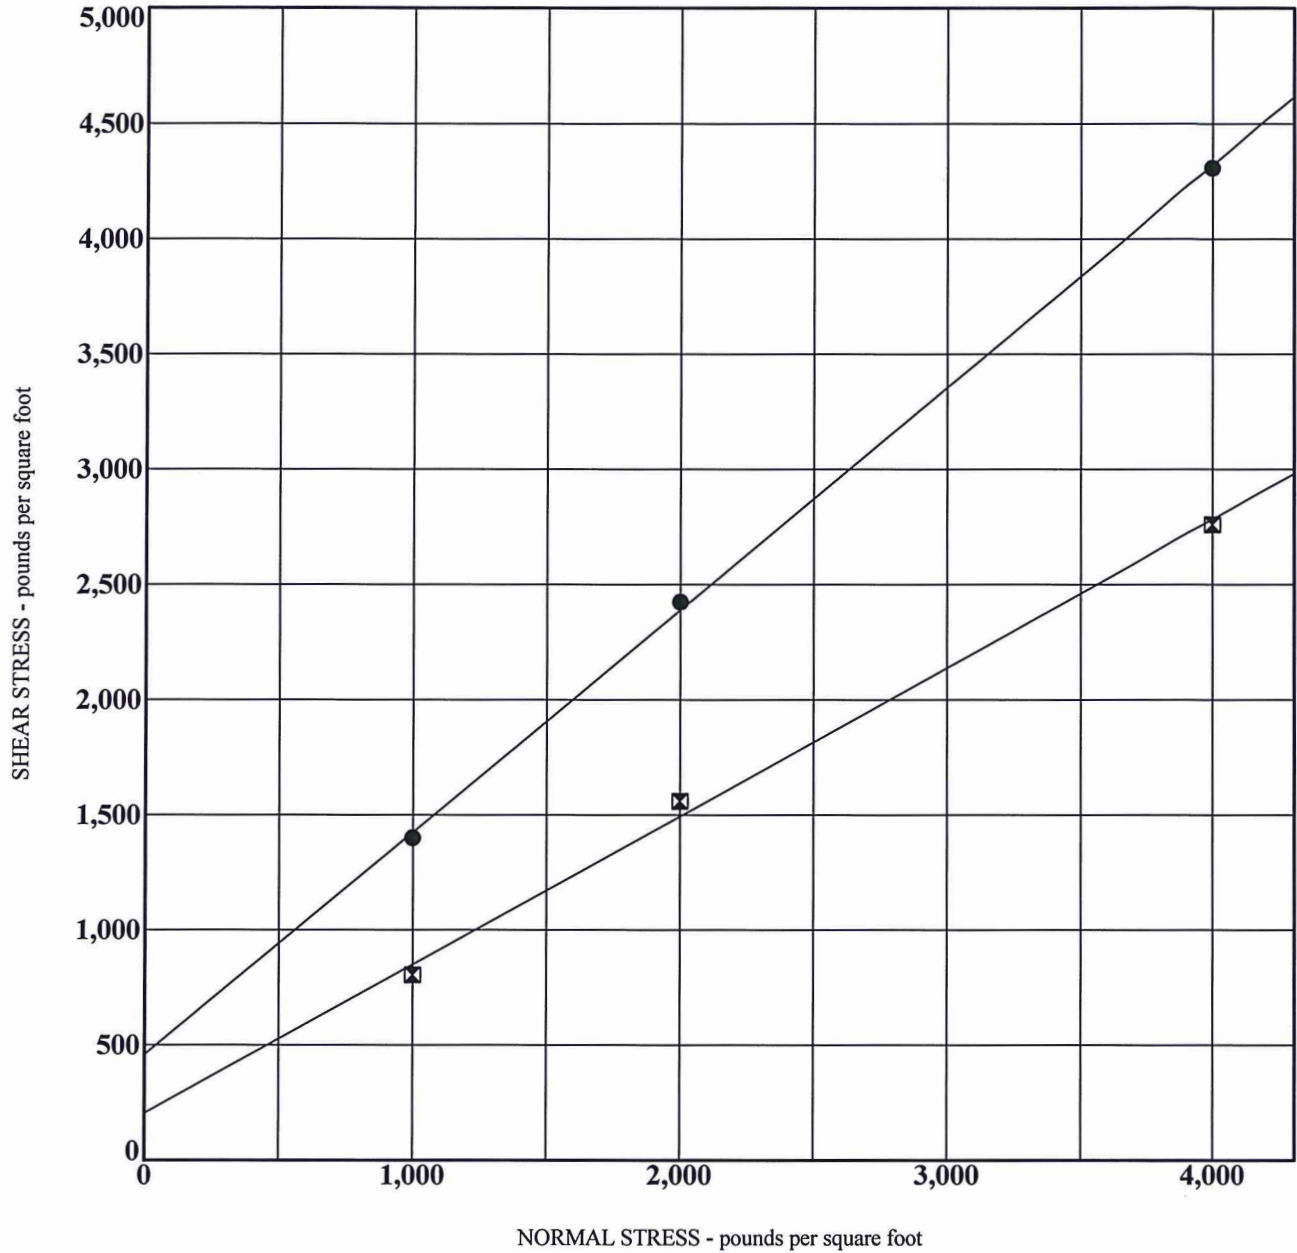
PLATE B-27

SAMPLE LOCATION	DESCRIPTION	FRICTION ANGLE (°)	COHESION (PSF)
● B-18 @ 10.0	Silty Sand (SM) - Ocotillo - Peak	44	460
☒ B-18 @ 10.0	Silty Sand (SM) - Ocotillo - Ultimate	33	200

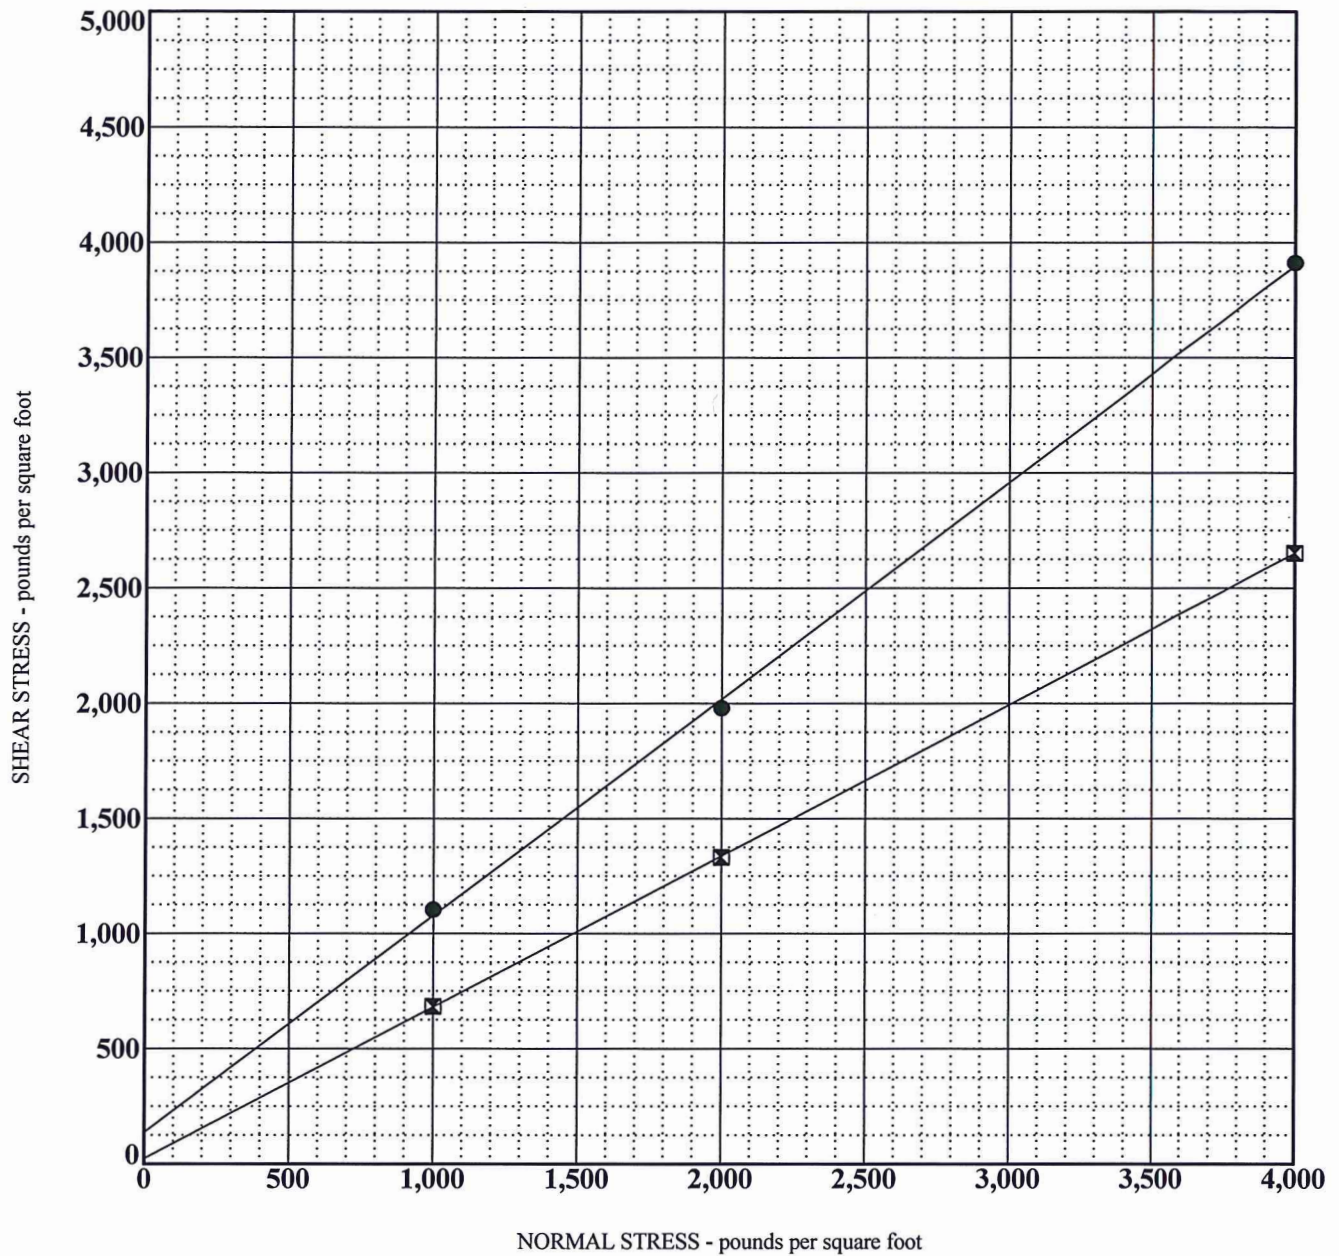
PLATE B-28

SAMPLE LOCATION	DESCRIPTION	FRICTION ANGLE (°)	COHESION (PSF)
● B-18 @ 15.2	Silty Sand (SM) - Ocotillo - Peak	43	140
☒ B-18 @ 15.2	Silty Sand (SM) - Ocotillo - Ultimate	33	20
