Appendix F1: Feasibility-Level Geotechnical Evaluation

*REVISED FEASIBILITY-LEVEL GEOTECHNICAL EVALUATION
KPC COACHELLA PROJECT
2,850-ACRES± OF VACANT LAND NORTH OF INTERSTATE 10
AND EAST OF THE ALL-AMERICAN CANAL
CITY OF COACHELLA, RIVERSIDE COUNTY, CALIFORNIA*

*March 23, 2023
J.N. 16-368
Revision 2*

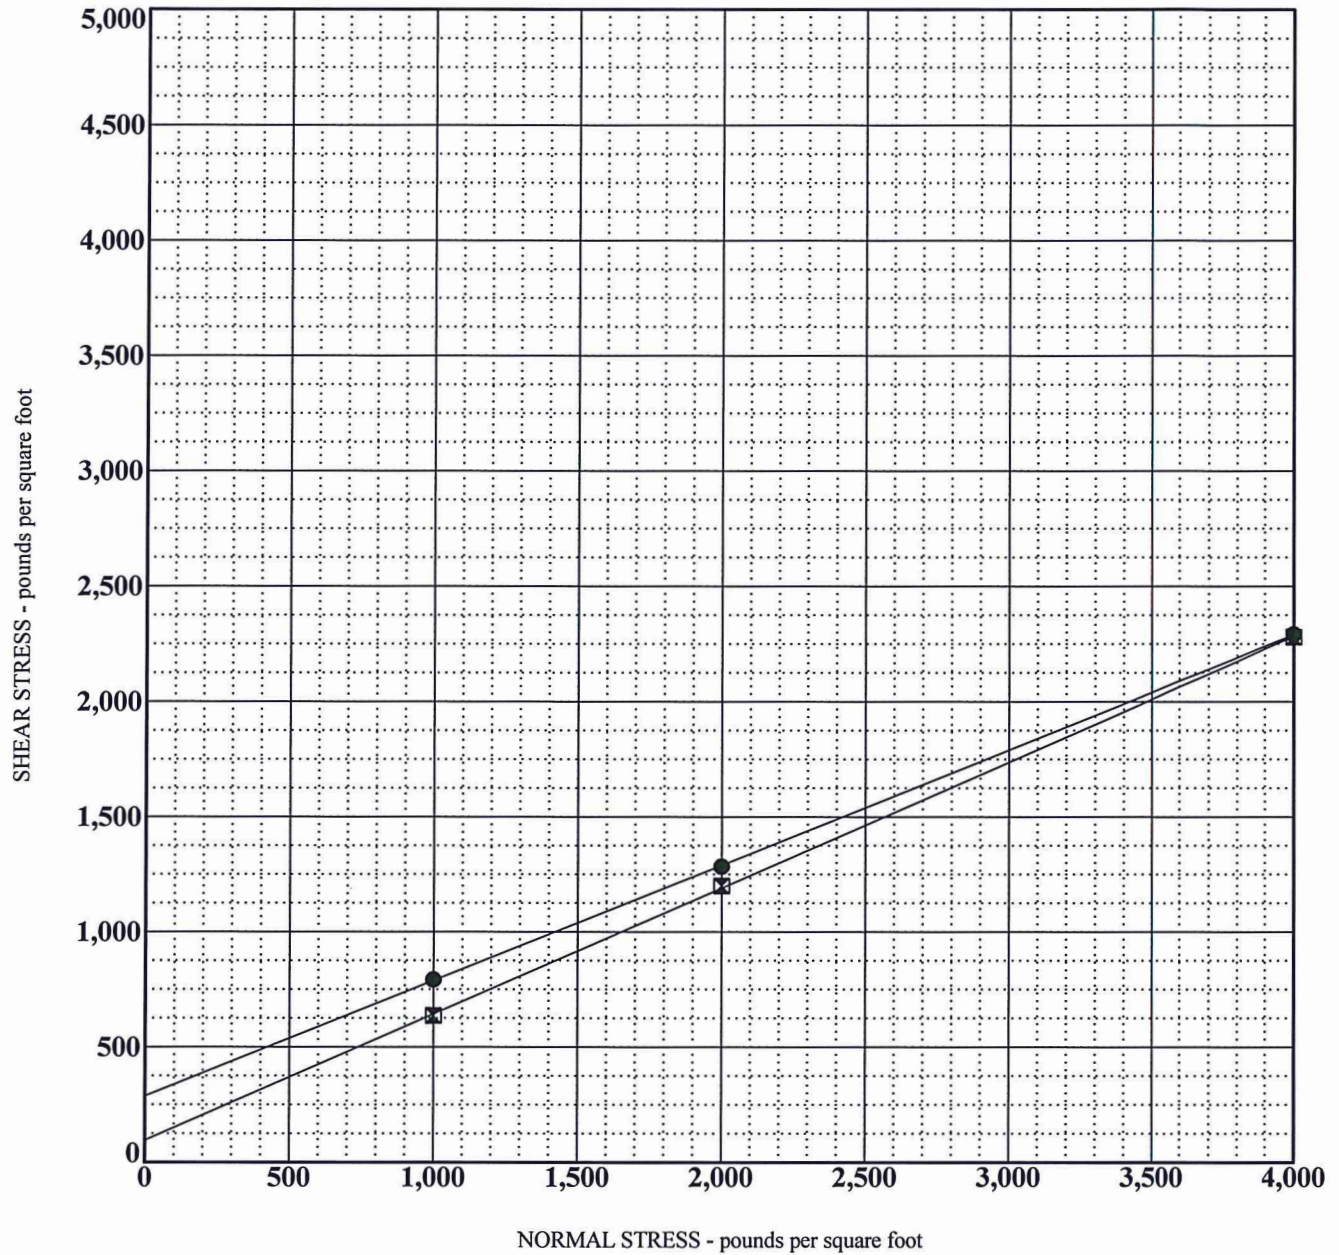
PLATE B-29

SAMPLE LOCATION	DESCRIPTION	FRICTION ANGLE (°)	COHESION (PSF)
● B-19 @ 5.1	Sandy Silt (ML) - Palm Spring FM - Peak	27	290
☒ B-19 @ 5.1	Sandy Silt (ML) - Palm Spring FM - Ultimate	29	100

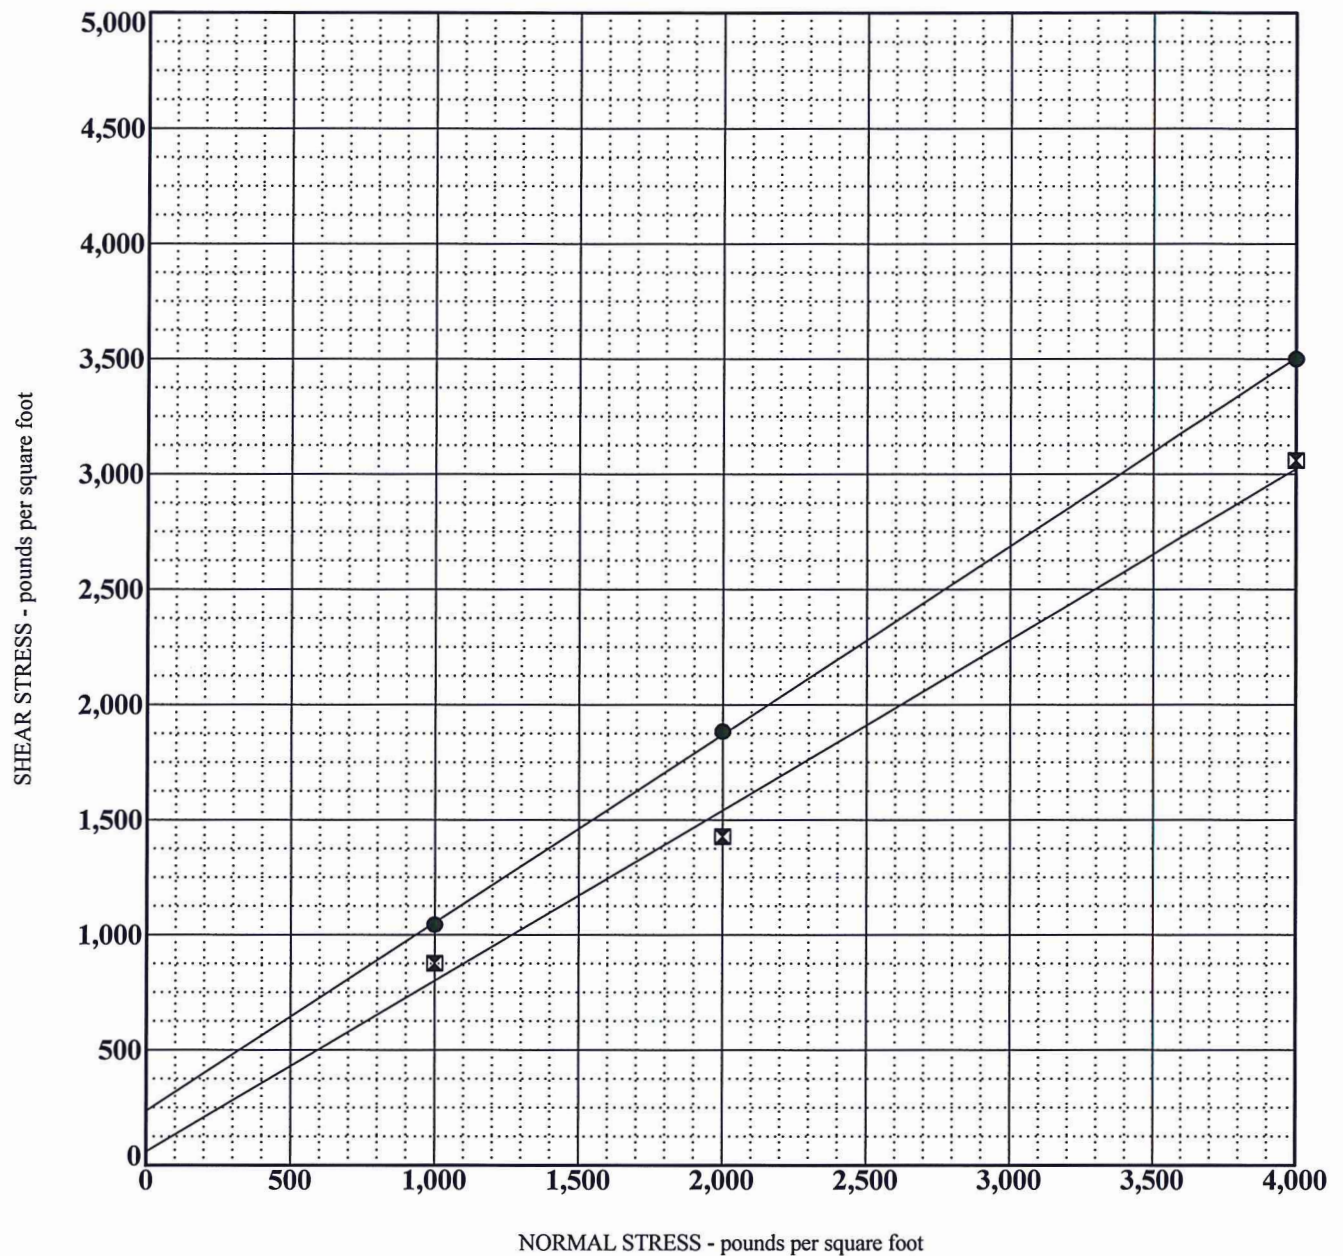
PLATE B-30

SAMPLE LOCATION	DESCRIPTION	FRICTION ANGLE (°)	COHESION (PSF)
● B-21 @ 10.0	Sand (SP) - Fan Deposits - Peak	39	240
☒ B-21 @ 10.0	Sand (SP) - Fan Deposits - Ultimate	37	60

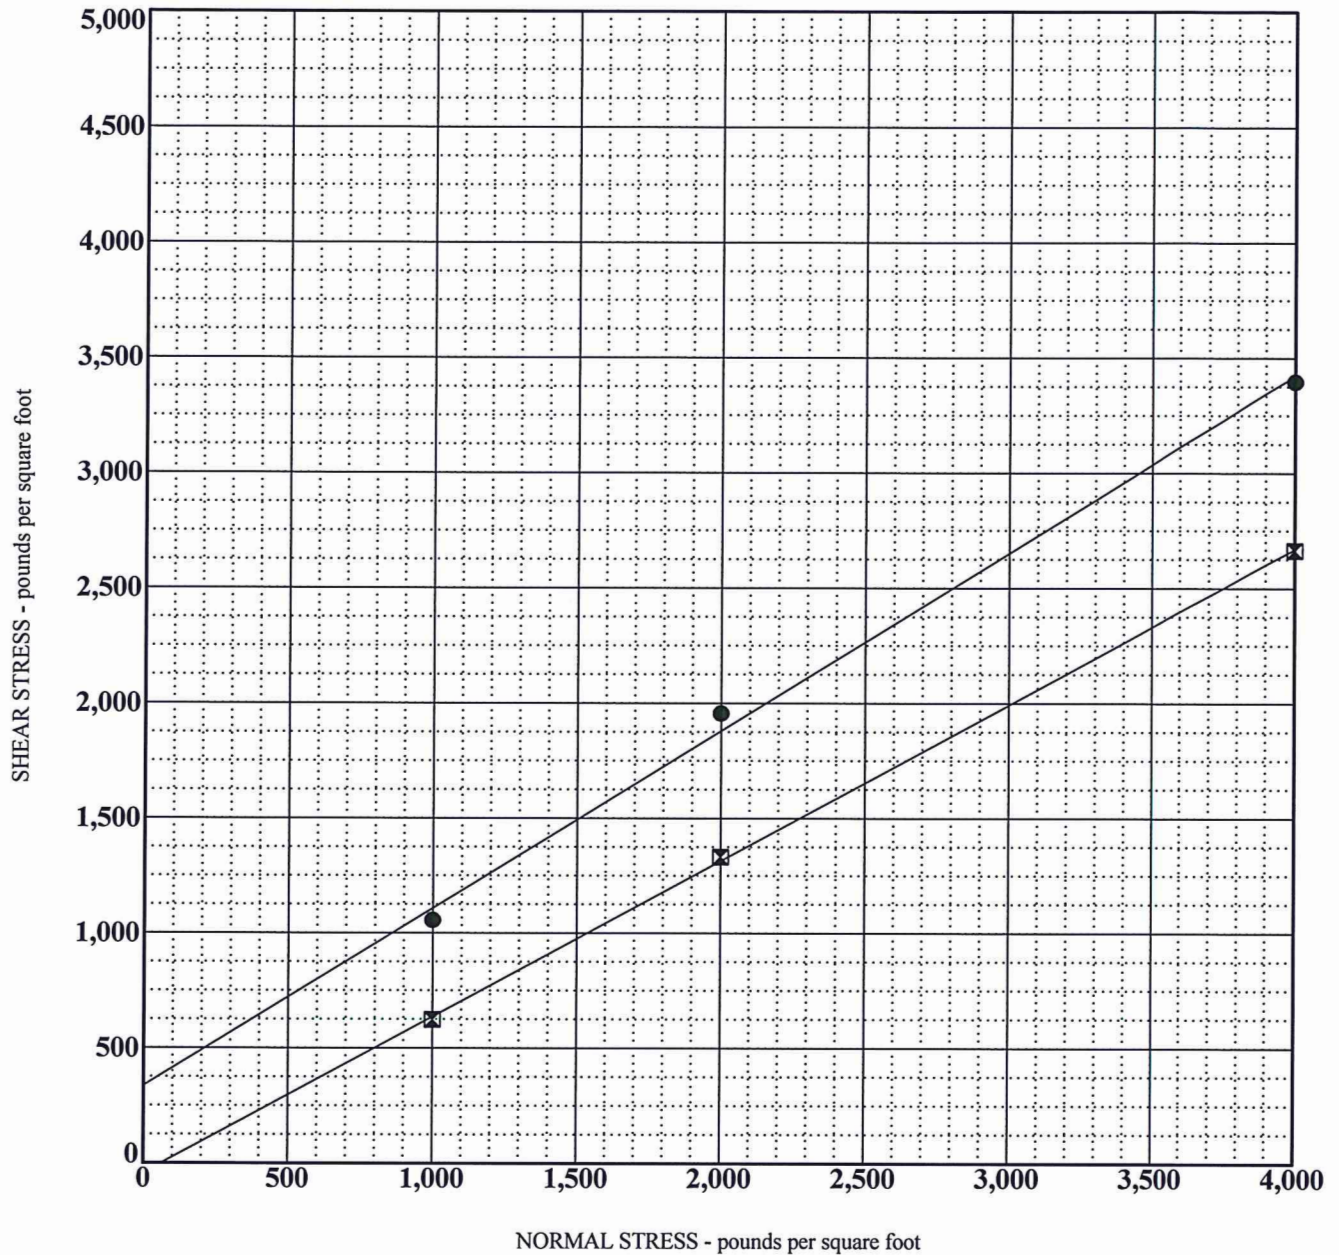
PLATE B-31

SAMPLE LOCATION	DESCRIPTION	FRICTION ANGLE (°)	COHESION (PSF)
● B-25 @ 0.0	Sand (SP-SM) - Fan Deposits - Peak	38	340
☒ B-25 @ 0.0	Sand (SP-SM) - Fan Deposits - Ultimate	34	0

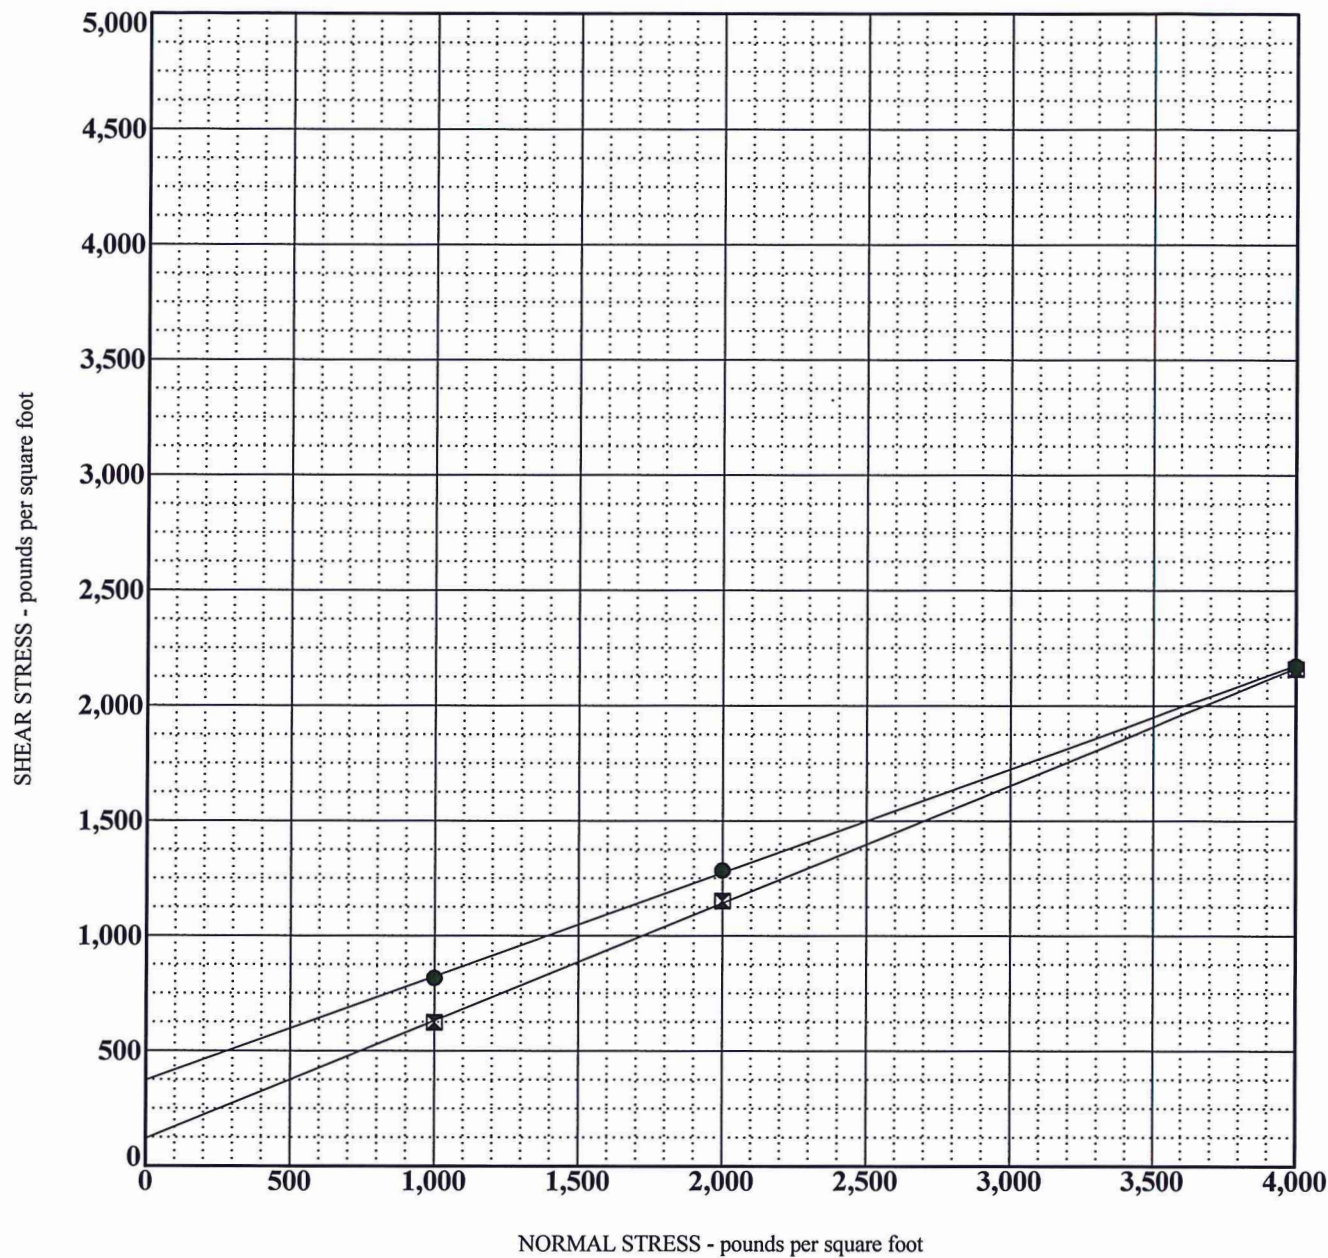
PLATE B-32

SAMPLE LOCATION	DESCRIPTION	FRICTION ANGLE (°)	COHESION (PSF)
● Outcrop#1 @ 0.0	Clayey Silt (CL) - Palm Spring FM - Peak	24	370
☒ Outcrop#1 @ 0.0	Clayey Silt (CL) - Palm Spring FM - Ultimate	27	120

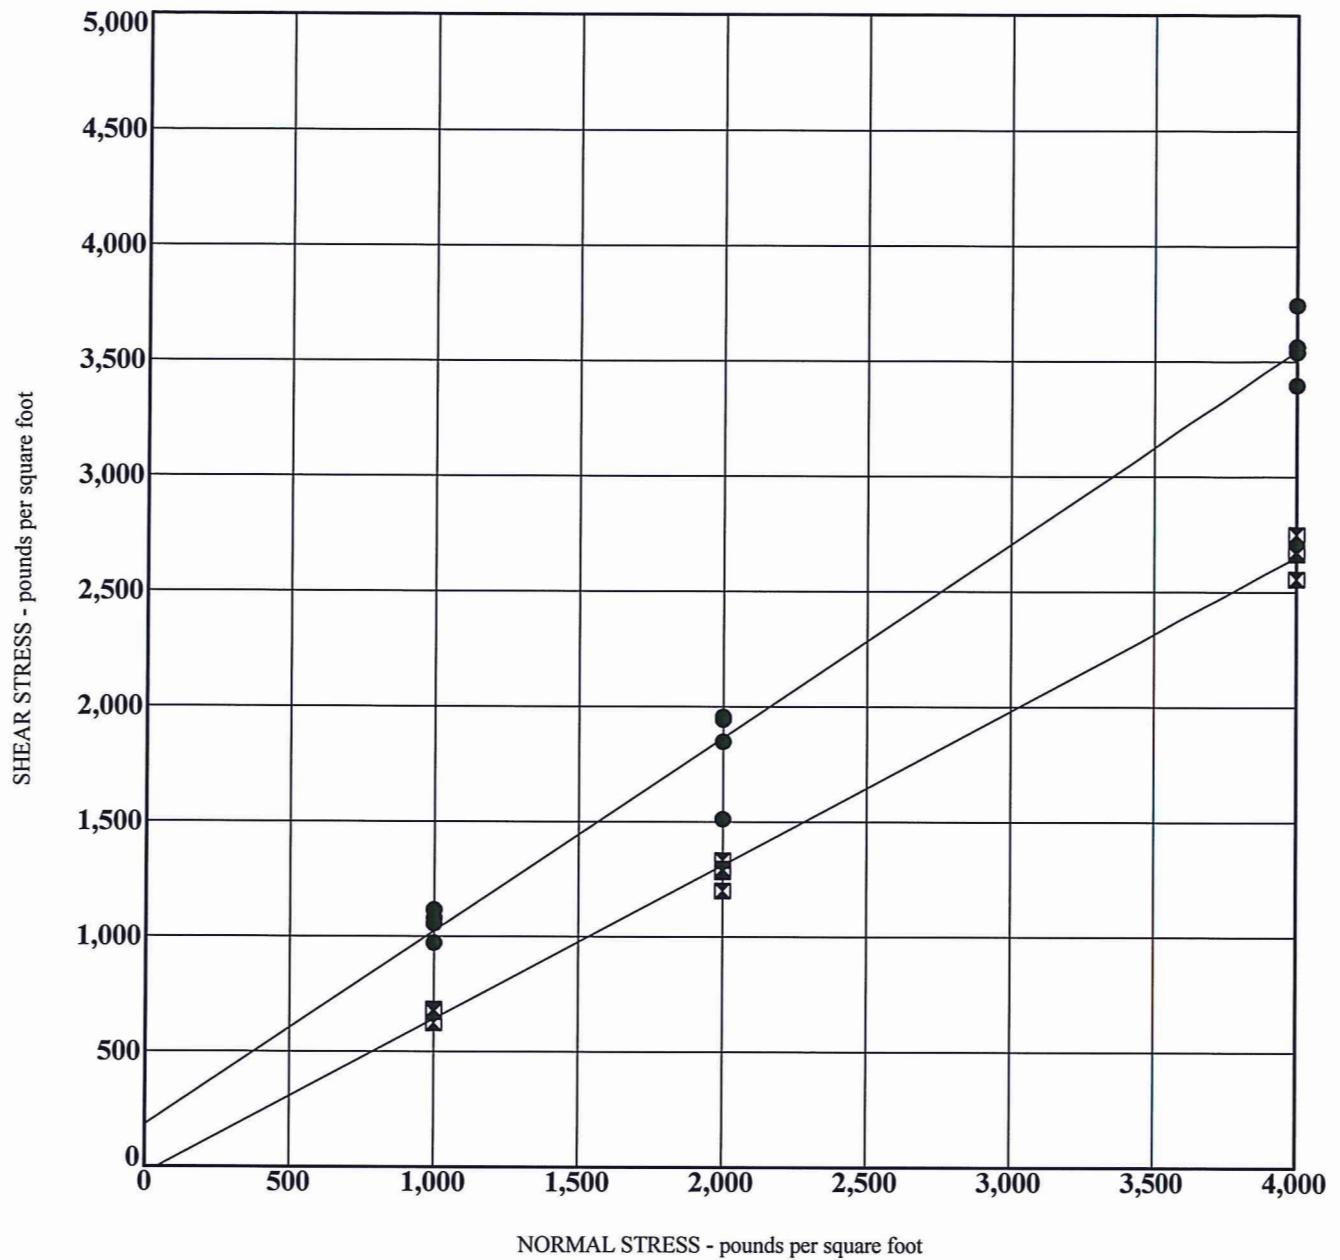
PLATE B-33

SAMPLE LOCATION	DESCRIPTION	FRICTION ANGLE (°)	COHESION (PSF)
● Qf-Comp-Rem @ 0.0	Sand (SW/SP) - Fan Deposits - Peak	40	180
✕ Qf-Comp-Rem @ 0.1	Sand (SW/SP) - Fan Deposits - Ultimate	34	0

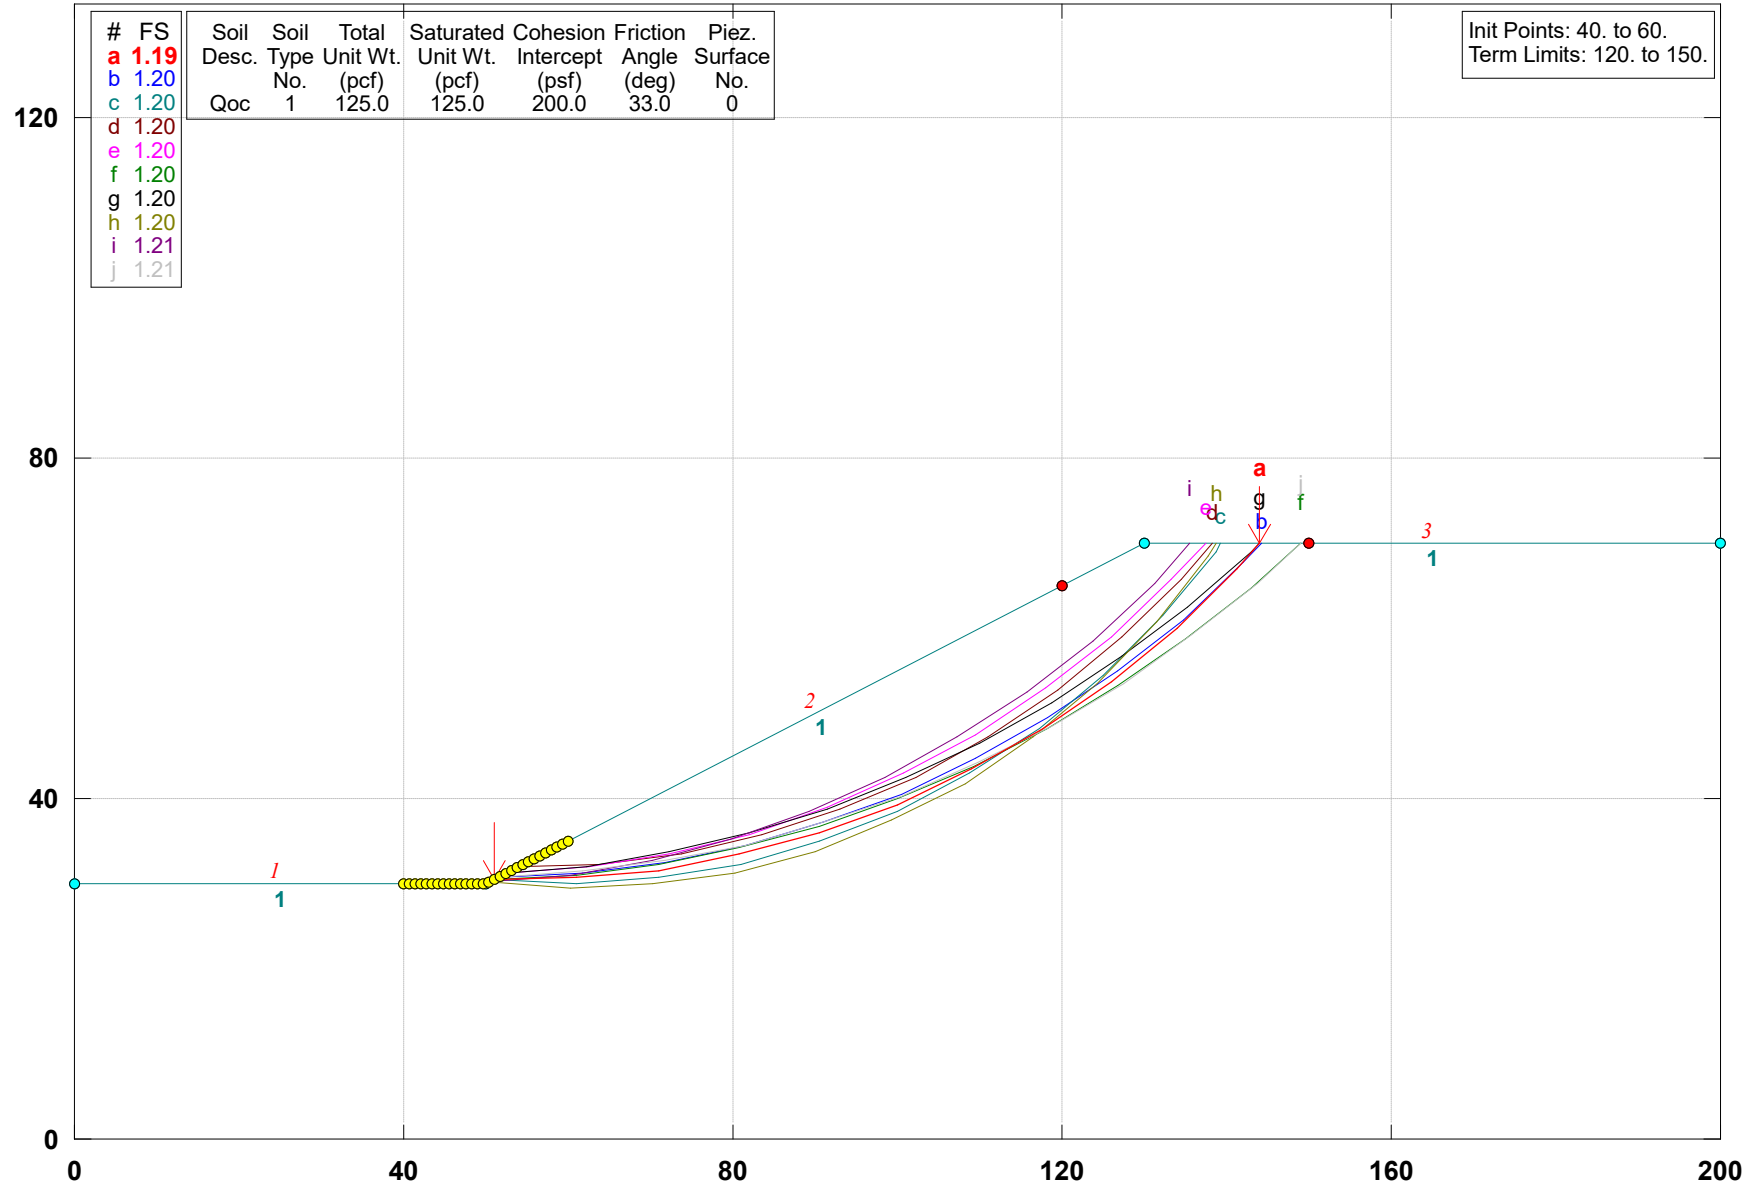
40' 2:1 Cut Slope, Ocotillo Conglomerate- SEISMIC

GSTABL7 v.2 FSmin=1.19
Safety Factors Are Calculated By The Modified Bishop Method

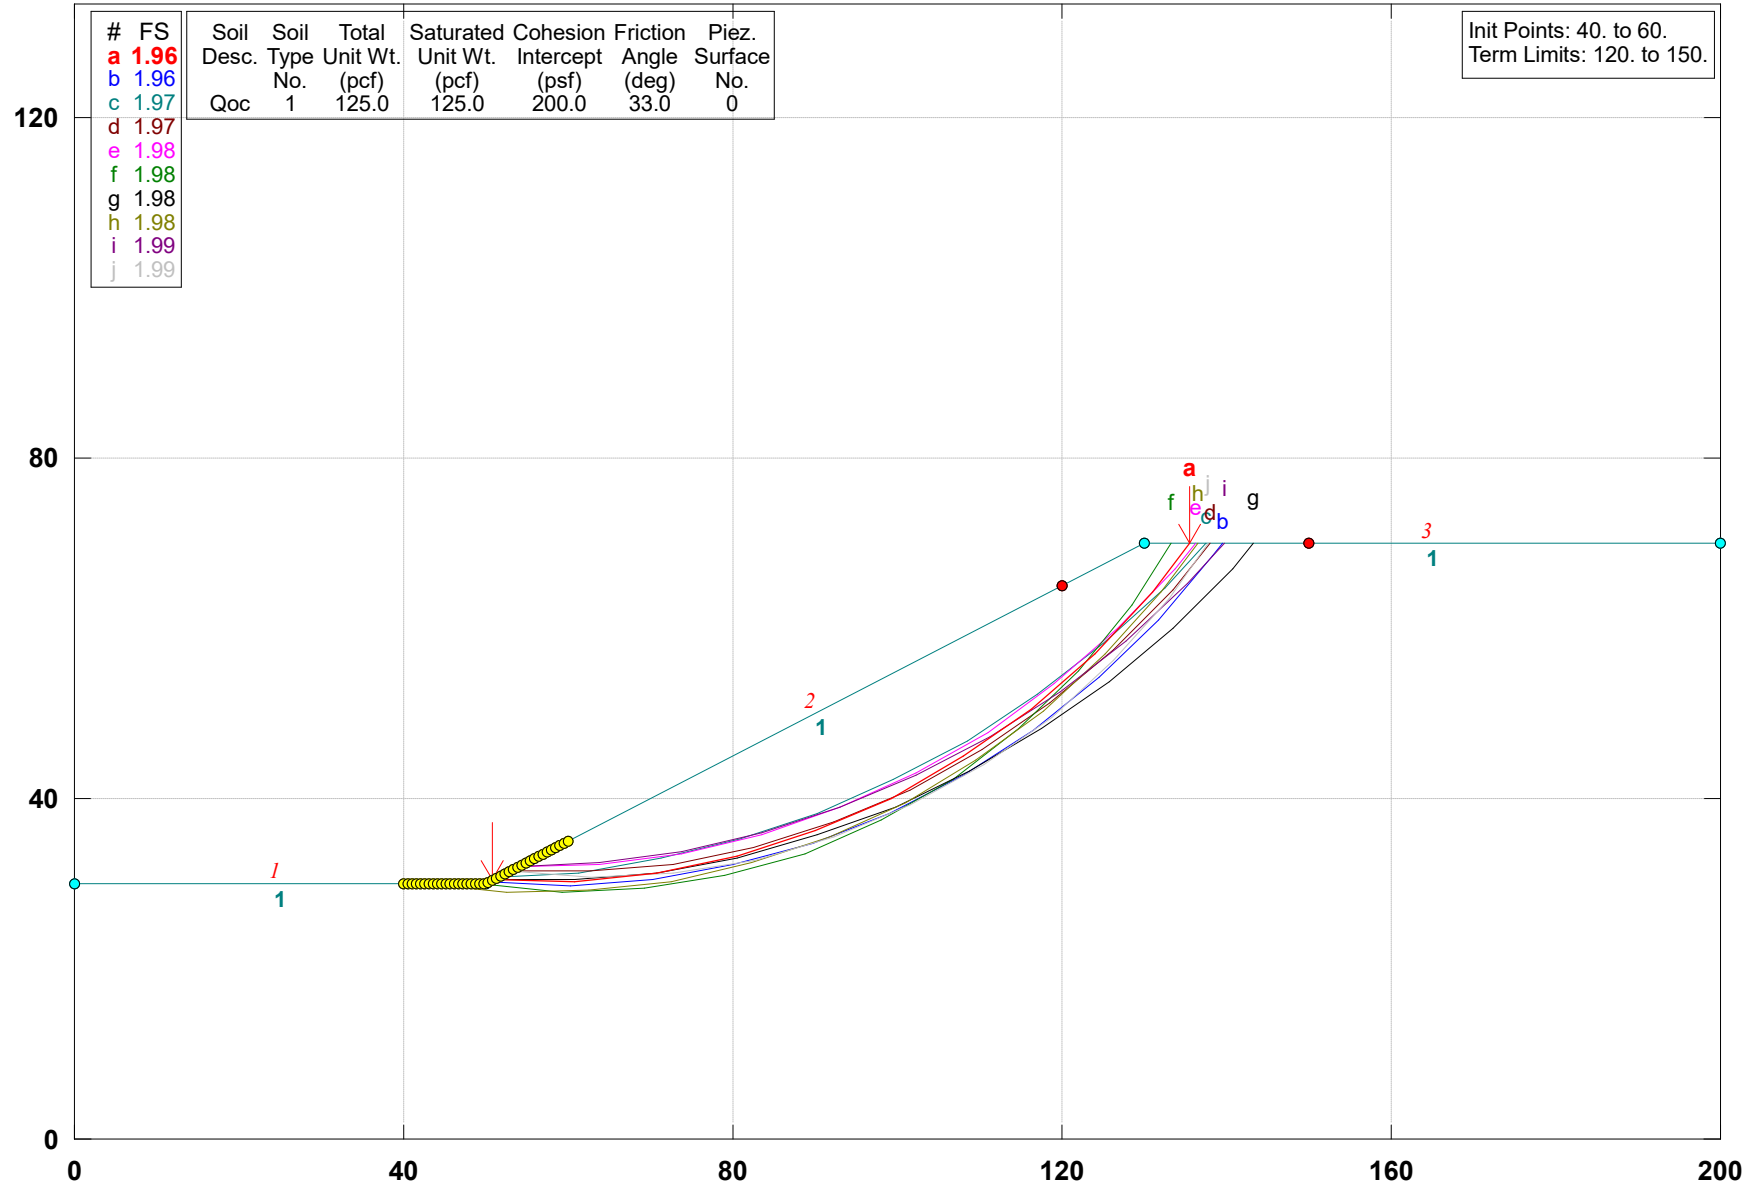
40' 2:1 Cut Slope, Ocotillo Conglomerate- STATIC

GSTABL7 v.2 FSmin=1.96

Safety Factors Are Calculated By The Modified Bishop Method

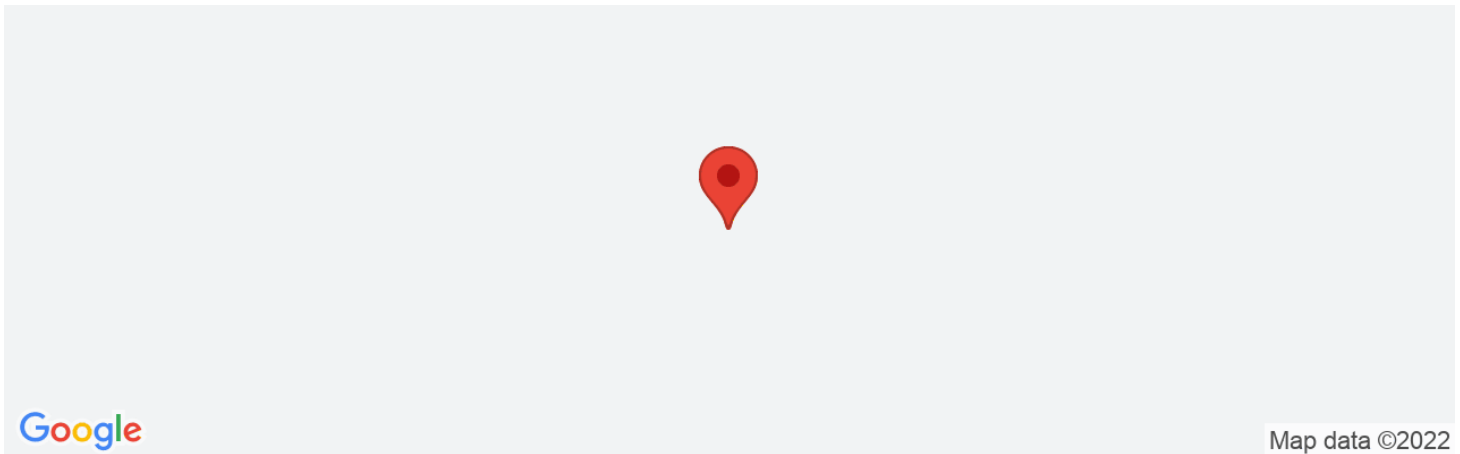
Date	10/6/2022, 2:01:32 PM
Design Code Reference Document	ASCE7-16
Risk Category	II
Site Class	C - Very Dense Soil and Soft Rock

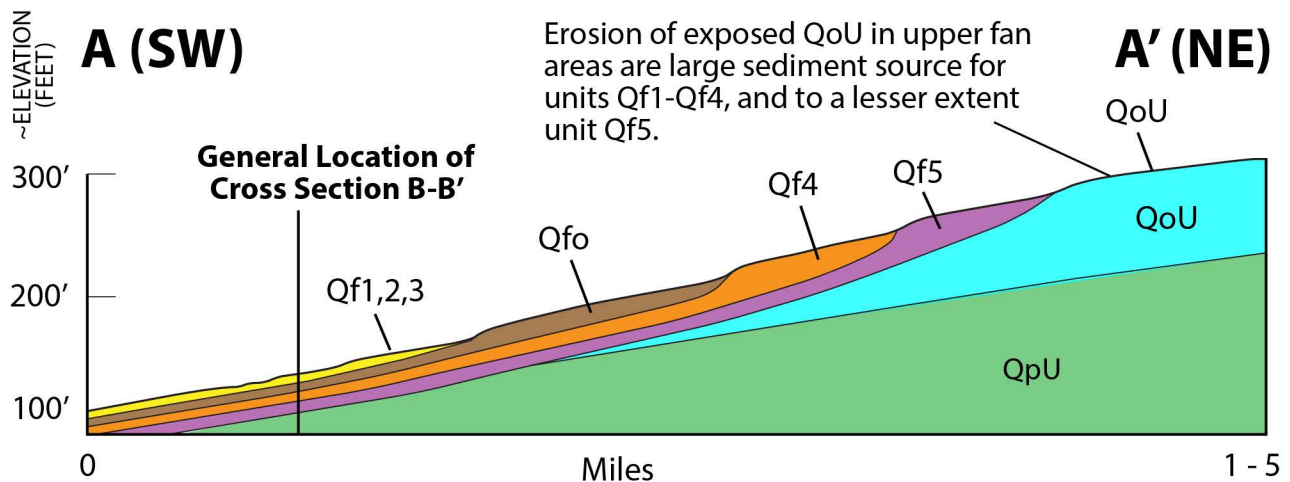
Cross Section A-A' shows the generalized stratigraphy going up a typical wash in the subject site extending close to the southern property boundary to the northern property boundary. Most trenches in this study excavated in the washes trend ~parallel to this cross section (See Plate GM1).

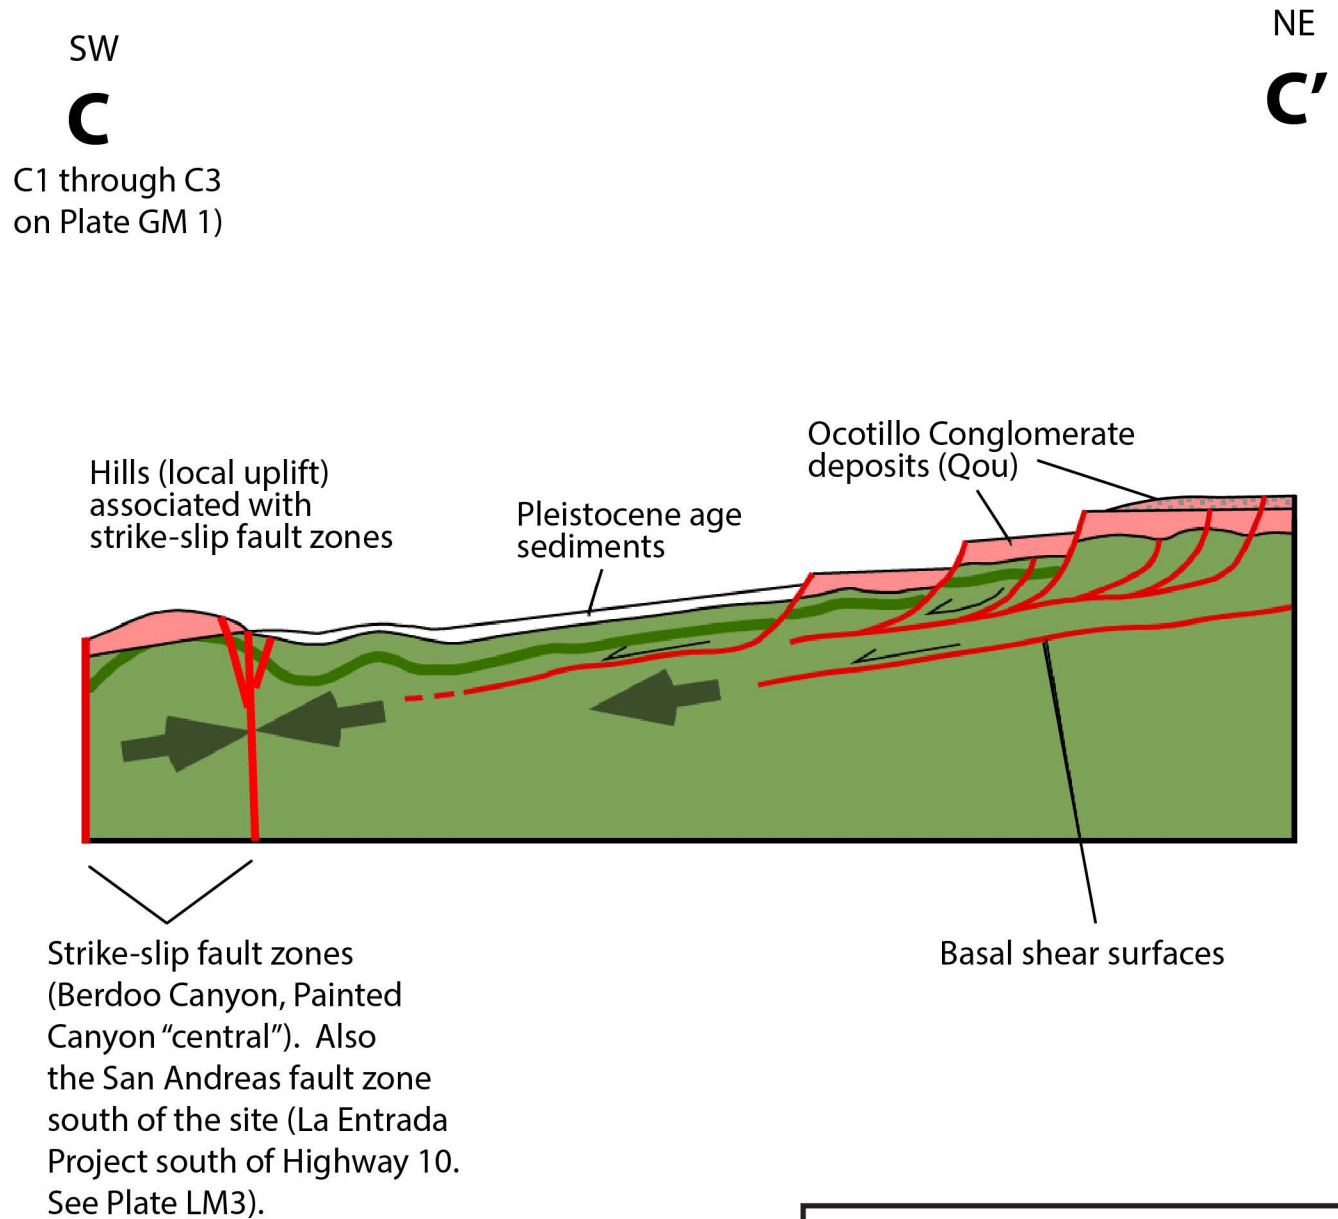
GENERALIZED FAULTING STRUCTURE OF THE COACHELLA FAN FAULT ZONE
