*FAULT INVESTIGATION REPORT
FOR LAND PLANNING PURPOSES
ALPINE ~280 PROPERTY
LOCATED EAST OF TYLER STREET,
WEST OF POLK STREET,
SOUTH OF I-10 AND NORTH OF AVENUE 48,
CITY OF COACHELLA,
RIVERSIDE COUNTY, CALIFORNIA*

*April 9, 2007
J.N. 621-05*

Subject: Fault Investigation Report for Land Planning Purposes, Alpine ~280 Property Located East of Tyler Street, West of Polk Street, South of I-10, and North of Avenue 48, City of Coachella, California.

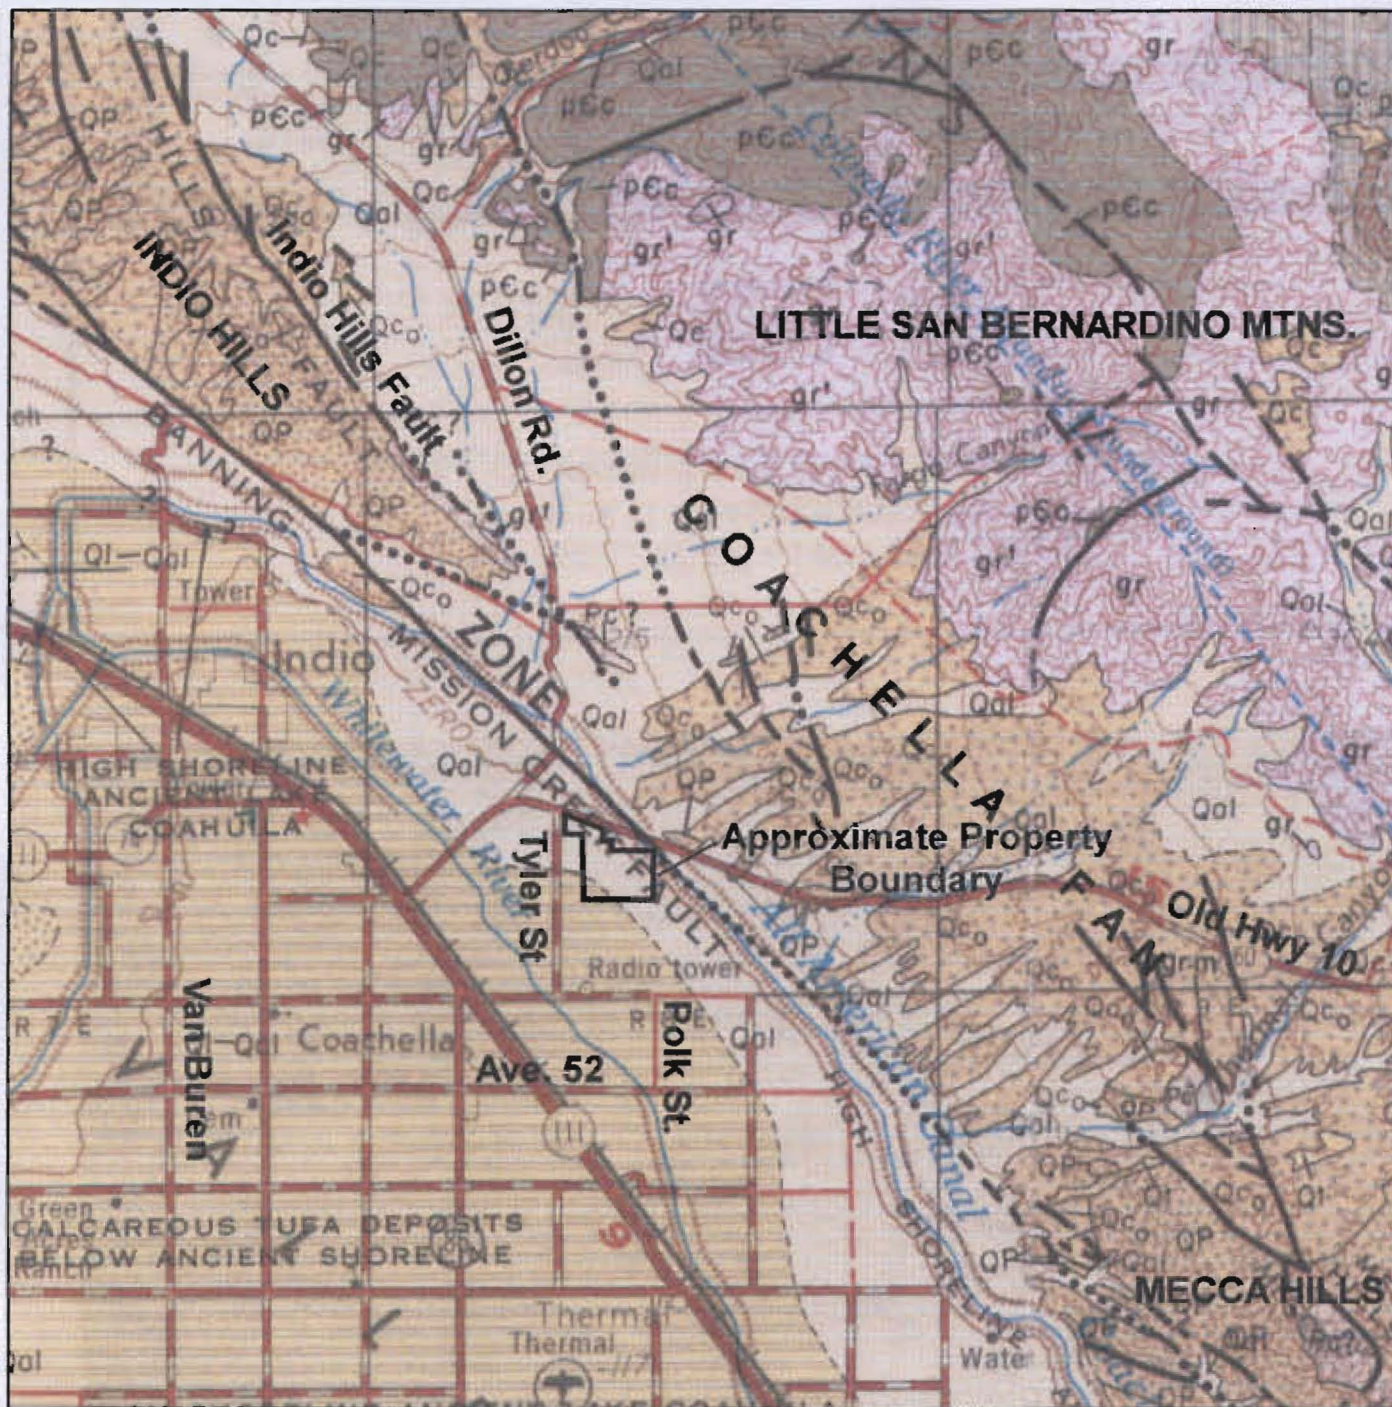
Regional Geology Map

Base Map: Geologic Map of California, Olaf P. Jenkins Edition, Santa Ana Sheet, Compilation by Thomas H. Rogers, 1965.
